Access Compliance Report

Public Rights-of-Way

(Curb Ramps)

Intersection ID: 10032513	Main Street: N_CASWELL_RD	Cross Street: N/A	Location: NE
ADA ID: B4F76433F7AF	Ramp Type: PerpDiag	Initial Pass/Fail: Fail	Overall Compliance: No
Severity Score: 13.75			
Codes/Mitigation Info/Possible Solution		Field Measurements/Component Compliance

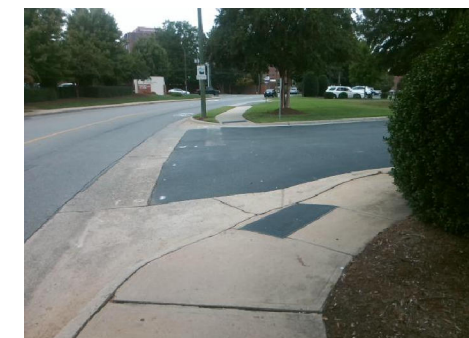
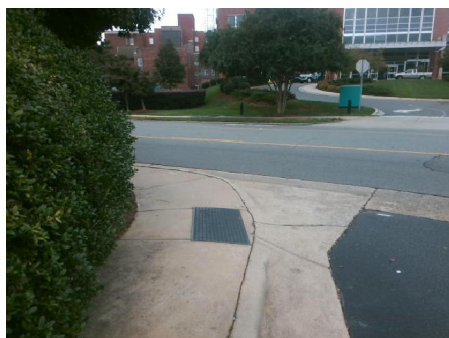
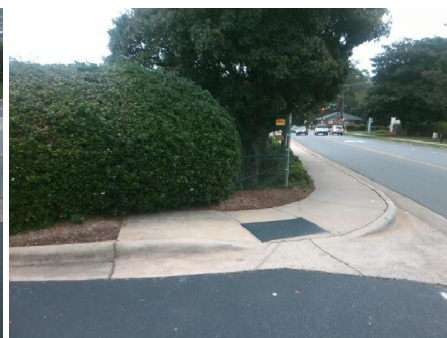
Not Found, R304.2.2, R304.5.3

Compliance	Description	Data	Compliance	Description	Data
N/A	Ramp Length (in)	30.0	No	Ramp Slope (%)	11.1
Yes	Ramp Width (in)	48.0	No	Ramp XSlope (%)	5.0
N/A	Flare Type LT	N/A	N/A	Flare Type RT	N/A
N/A	Flare Slope LT (%)	N/A	N/A	Flare Slope RT (%)	N/A
N/A	Flare Traversable LT?	N/A	N/A	Flare Traversable RT?	N/A
N/A	Landing Length (in)	N/A	N/A	DWS Provided?	N/A
N/A	Landing Width (in)	N/A	N/A	DWS Contrast?	N/A
N/A	Landing Slope (%)	N/A	N/A	DWS Length (in)	N/A
N/A	Landing X Slope (%)	N/A	N/A	DWS Full Width?	N/A
N/A	Landing Curb? (Y/N)	N/A	N/A	DWS Offset (in)	N/A
N/A	Shared Landing?	N/A			
N/A	Gutter Ponding?	N/A	N/A	Gutter Slope (%)	N/A
N/A	Gutter Lip Ht (in)	N/A	N/A	Gutter X Slope (%)	N/A
N/A	Painted X Walk1?	No	N/A	Painted X Walk2?	No
	X Walk 1 Direction	To W		X Walk 2 Direction	To SE
N/A	X Walk 1 Width (in)	N/A	N/A	X Walk 2 Width (in)	N/A
	X Walk 1 Slope (%)	3.5		X Walk 2 Slope (%)	2.4
	X Walk 1 X Slope (%)	3.7		X Walk 2 X Slope (%)	0.8

N/A	Ramp inside XWalk1?	N/A	N/A	Ramp inside XWalk2?	N/A
	Road Slope (%)	6.2	N/A	Clear Space?	N/A
	Road X Slope (%)	1.7	N/A	Clear Space to XWalk (in)	N/A
N/A	Any Obstructions?	N/A	N/A	Storm Grate/Utility Hazard?	N/A
	Obstruction Type			Storm Grate/Utility Type	
		N/A			N/A
			Yes	Surface Condition? (G/P)	Good

Remove & Replace Curb Ramp With Two New Directional Ramps or Equivalent.
