Access Compliance Report Public Rights-of-Way (Curb Ramps)

Intersection ID: 30227 Main Street: CLARA_DUNN_LN Cross Street: PATRICIA_RYAN_DR Location: S

ADA ID: B4F7ED7FD963 Ramp Type: BlendTrans1 Initial Pass/Fail: Fail Overall Compliance: No Severity Score: 10

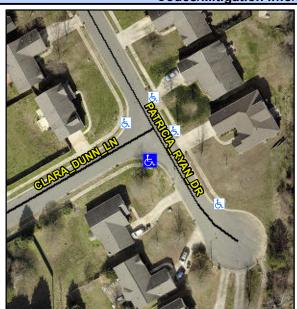
NO LT SW

Not Found, R304.5.1, R304.5.3

Compliance Description Data Compliance Description Data Yes BlendTrans Slope (%) N/A Ramp Length (in) 46.5 3.1 42.5 No No Ramp Width (in) BlendTrans XSlope (%) 4.0 N/A N/A Flare Type LT N/A Flare Type RT N/A N/A Flare Slope LT (%) N/A N/A Flare Slope RT (%) N/A N/A Flare Traversable LT? N/A N/A Flare Traversable RT? N/A N/A Landing Length (in) N/A N/A **DWS Provided?** N/A N/A Landing Width (in) N/A N/A **DWS Contrast?** N/A N/A N/A N/A Landing Slope (%) DWS Length (in) N/A N/A Landing X Slope (%) N/A N/A DWS Full Width? N/A N/A Landing Curb? (Y/N) N/A N/A DWS Offset (in) N/A N/A N/A Shared Landing? N/A **Gutter Ponding?** N/A N/A Gutter Slope (%) N/A N/A Gutter Lip Ht (in) N/A N/A Gutter X Slope (%) N/A N/A Painted X Walk1? No N/A Painted X Walk2? No X Walk 1 Direction To NW X Walk 2 Direction To NE N/A X Walk 1 Width (in) X Walk 2 Width (in) N/A X Walk 1 Slope (%) 2.8 X Walk 2 Slope (%) 3.5 X Walk 1 X Slope (%) 4.6 X Walk 2 X Slope (%) 0.6 N/A N/A Ramp inside XWalk2? N/A N/A Ramp inside XWalk1? Road Slope (%) 3.5 Clear Space? N/A Road X Slope (%) 0.8 N/A Clear Space to XWalk (in) N/A N/A N/A N/A Any Obstructions? Storm Grate/Utility Hazard? N/A **Obstruction Type** Storm Grate/Utility Type N/A N/A Yes Surface Condition? (G/P) Good

Remove & Replace Curb Ramp With Two New Directional Ramps or Equivalent.
