Access Compliance Report

Public Rights-of-Way

(Curb Ramps)

Intersection ID: 49506	Main Street: OSCEOLA_LN	Cross Street: WATERLOO_DR	Location: S
ADA ID: B4FCD585CC2D	Ramp Type: PerpDiag	Initial Pass/Fail: Fail	Overall Compliance: No
Severity Score: 22.5			
Codes/Mitigation Info/Possible Solution		Field Measurements/Component Compliance

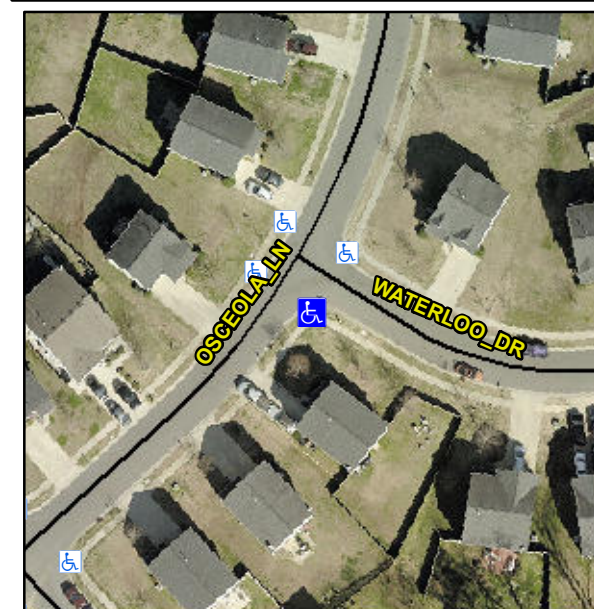
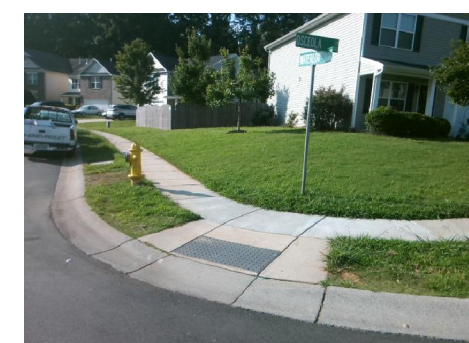
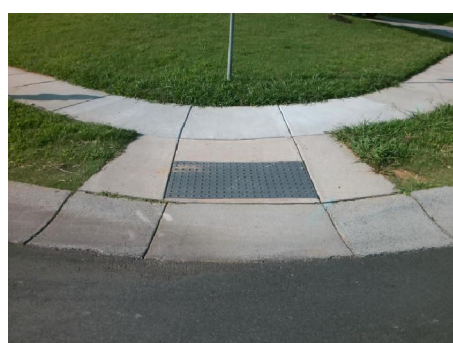
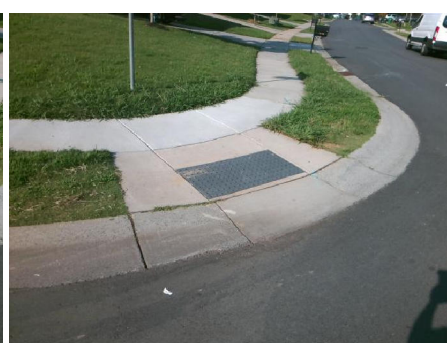
Not Found, R304.5.1, R304.2.2, R304.5.3

Compliance	Description	Data	Compliance	Description	Data
N/A	Ramp Length (in)	46.0	No	Ramp Slope (%)	9.2
No	Ramp Width (in)	47.5	No	Ramp XSlope (%)	3.8
N/A	Flare Type LT	N/A	N/A	Flare Type RT	N/A
N/A	Flare Slope LT (%)	N/A	N/A	Flare Slope RT (%)	N/A
N/A	Flare Traversable LT?	N/A	N/A	Flare Traversable RT?	N/A
N/A	Landing Length (in)	N/A	N/A	DWS Provided?	N/A
N/A	Landing Width (in)	N/A	N/A	DWS Contrast?	N/A
N/A	Landing Slope (%)	N/A	N/A	DWS Length (in)	N/A
N/A	Landing X Slope (%)	N/A	N/A	DWS Full Width?	N/A
N/A	Landing Curb? (Y/N)	N/A	N/A	DWS Offset (in)	N/A
N/A	Shared Landing?	N/A			
N/A	Gutter Ponding?	N/A	N/A	Gutter Slope (%)	N/A
N/A	Gutter Lip Ht (in)	N/A	N/A	Gutter X Slope (%)	N/A
N/A	Painted X Walk1?	No	N/A	Painted X Walk2?	No
	X Walk 1 Direction	To NE		X Walk 2 Direction	To NW
N/A	X Walk 1 Width (in)	N/A	N/A	X Walk 2 Width (in)	N/A
	X Walk 1 Slope (%)	0.7		X Walk 2 Slope (%)	4.6
	X Walk 1 X Slope (%)	3.6		X Walk 2 X Slope (%)	0.7

N/A	Ramp inside XWalk1?	N/A	N/A	Ramp inside XWalk2?	N/A
	Road Slope (%)	3.4	N/A	Clear Space?	N/A
	Road X Slope (%)	2.8	N/A	Clear Space to XWalk (in)	N/A
N/A	Any Obstructions?	N/A	N/A	Storm Grate/Utility Hazard?	N/A
	Obstruction Type			Storm Grate/Utility Type	
		N/A			N/A
			Yes	Surface Condition? (G/P)	Good

Remove & Replace Curb Ramp With Two New Directional Ramps or Equivalent.
