# Access Compliance Report

## Public Rights-of-Way

### (Curb Ramps)

Intersection ID: 47269	Main Street: E_MCCULLOUGH_DR	Cross Street: KEN_HOFFMAN_DR	Location: S
ADA ID: B505303CE70F	Ramp Type: Perp	Initial Pass/Fail: Fail	Overall Compliance: No
		Severity Score: 0

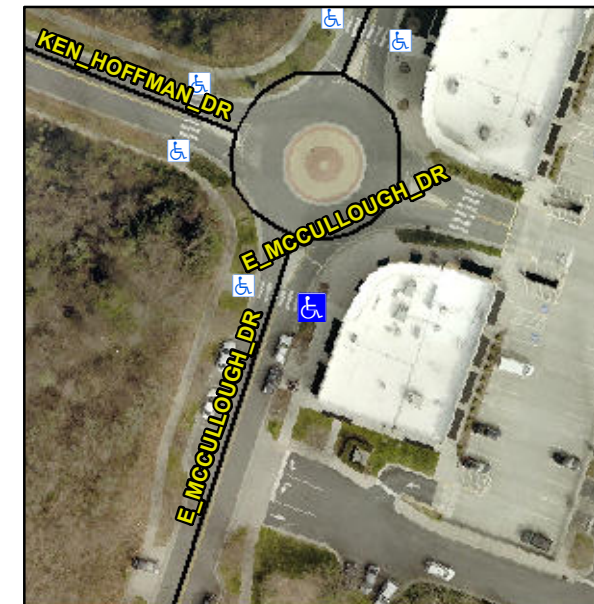
Compliance	Description	Data	Compliance	Description	Data
N/A	Ramp Length (in)	93.0	Yes	Ramp Slope (%)	5.7
Yes	Ramp Width (in)	71.0	Yes	Ramp XSlope (%)	1.5
N/A	Flare Type LT	N/A	N/A	Flare Type RT	N/A
N/A	Flare Slope LT (%)	N/A	N/A	Flare Slope RT (%)	N/A
N/A	Flare Traversable LT?	N/A	N/A	Flare Traversable RT?	N/A
N/A	Landing Length (in)	N/A	N/A	DWS Provided?	N/A
N/A	Landing Width (in)	N/A	N/A	DWS Contrast?	N/A
N/A	Landing Slope (%)	N/A	N/A	DWS Length (in)	N/A
N/A	Landing X Slope (%)	N/A	N/A	DWS Full Width?	N/A
N/A	Landing Curb? (Y/N)	N/A	N/A	DWS Offset (in)	N/A
N/A	Shared Landing?	N/A			
N/A	Gutter Ponding?	N/A	N/A	Gutter Slope (%)	N/A
N/A	Gutter Lip Ht (in)	N/A	N/A	Gutter X Slope (%)	N/A
N/A	Painted X Walk1?	Yes	N/A	Painted X Walk2?	N/A
	X Walk 1 Direction	To NW		X Walk 2 Direction	N/A
N/A	X Walk 1 Width (in)	116.0	N/A	X Walk 2 Width (in)	N/A
	X Walk 1 Slope (%)	3.1		X Walk 2 Slope (%)	N/A
	X Walk 1 X Slope (%)	0.2		X Walk 2 X Slope (%)	N/A

N/A	Ramp inside XWalk1?	Yes	N/A	Ramp inside XWalk2?	N/A
	Road Slope (%)	N/A	N/A	Clear Space?	N/A
	Road X Slope (%)	N/A	N/A	Clear Space to XWalk (in)	N/A
N/A	Any Obstructions?	N/A	N/A	Storm Grate/Utility Hazard?	N/A
	Obstruction Type			Storm Grate/Utility Type	
		N/A			N/A
			Yes	Surface Condition? (G/P)	Good

**Remove & Replace Entire Ramp.**

Total Cost: \$ 1850.00
