# Access Compliance Report

## Public Rights-of-Way

### (Curb Ramps)

Intersection ID: N/A	Main Street: WENDOVER_CR	Cross Street: SHARON_RD	Location: NW
ADA ID: B50EE4E1B936	Ramp Type: PerpDiag	Initial Pass/Fail: Fail	Overall Compliance: No
			Severity Score: 26.25

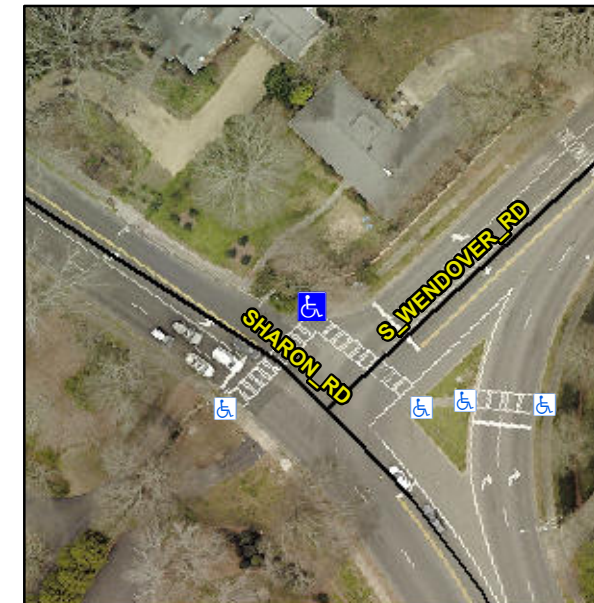
**Not Found, R304.2.2, R304.5.3**

Compliance	Description	Data	Compliance	Description	Data
N/A	Ramp Length (in)	62.0	No	Ramp Slope (%)	14.3
Yes	Ramp Width (in)	48.0	No	Ramp XSlope (%)	2.9
N/A	Flare Type LT	N/A	N/A	Flare Type RT	N/A
N/A	Flare Slope LT (%)	N/A	N/A	Flare Slope RT (%)	N/A
N/A	Flare Traversable LT?	N/A	N/A	Flare Traversable RT?	N/A
N/A	Landing Length (in)	N/A	N/A	DWS Provided?	N/A
N/A	Landing Width (in)	N/A	N/A	DWS Contrast?	N/A
N/A	Landing Slope (%)	N/A	N/A	DWS Length (in)	N/A
N/A	Landing X Slope (%)	N/A	N/A	DWS Full Width?	N/A
N/A	Landing Curb? (Y/N)	N/A	N/A	DWS Offset (in)	N/A
N/A	Shared Landing?	N/A			
N/A	Gutter Ponding?	N/A	N/A	Gutter Slope (%)	N/A
N/A	Gutter Lip Ht (in)	N/A	N/A	Gutter X Slope (%)	N/A
N/A	Painted X Walk1?	Yes	N/A	Painted X Walk2?	Yes
	X Walk 1 Direction	To SW		X Walk 2 Direction	To SE
N/A	X Walk 1 Width (in)	104.0	N/A	X Walk 2 Width (in)	94.0
	X Walk 1 Slope (%)	1.6		X Walk 2 Slope (%)	0.8
	X Walk 1 X Slope (%)	0.5		X Walk 2 X Slope (%)	0.1

N/A	Ramp inside XWalk1?	Yes	N/A	Ramp inside XWalk2?	Yes
	Road Slope (%)	0.8	N/A	Clear Space?	N/A
	Road X Slope (%)	1.6	N/A	Clear Space to XWalk (in)	N/A
N/A	Any Obstructions?	N/A	N/A	Storm Grate/Utility Hazard?	N/A
	Obstruction Type			Storm Grate/Utility Type	
		N/A			N/A
			Yes	Surface Condition? (G/P)	Good

**Remove & Replace Curb Ramp With Two New Directional Ramps or Equivalent.**
