Access Compliance Report

Public Rights-of-Way

(Curb Ramps)

| Intersection ID: 3129 | Main Street: ALAMEDA_LN | Cross Street: AVALON_FOREST_LN | Location: E |

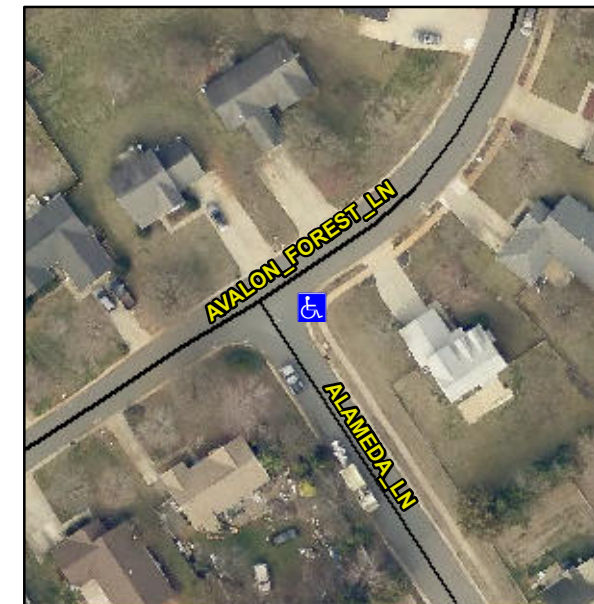
| ADA ID: B50FAE4A787A | Ramp Type: Perp | Initial Pass/Fail: Fail | Overall Compliance: No |

Not Found, R304.5.1

| Compliance | Description | Data | Compliance | Description | Data |
|---|---|---|---|---|---|
| N/A | Ramp Length (in) | 48.0 | Yes | Ramp Slope (%) | 7.0 |
| No | Ramp Width (in) | 47.0 | Yes | Ramp XSlope (%) | 0.8 |

Remove & Replace Entire Ramp.
