# Access Compliance Report

## Public Rights-of-Way

### (Curb Ramps)

Intersection ID: 7311	Main Street: CLAREMONT_RD	Cross Street: MOORES_CHAPEL_RD	Location:	N/A
ADA ID: B51927A8264D	Ramp Type: Perp	Initial Pass/Fail: Fail	Overall Compliance: No	Severity Score: 10
Codes/Mitigation Info/Possible Solution		Field Measurements/Component Compliance

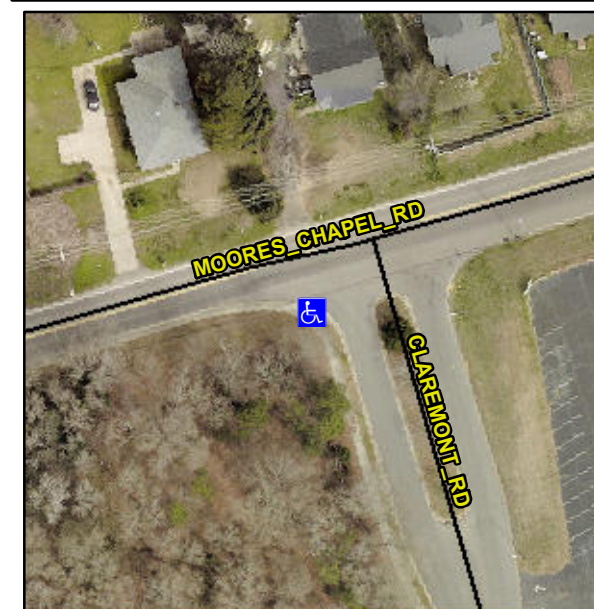
**Not Found, R304.5.1, R304.5.3**

Compliance	Description	Data	Compliance	Description	Data
N/A	Ramp Length (in)	92.0	Yes	Ramp Slope (%)	6.3
No	Ramp Width (in)	47.0	No	Ramp XSlope (%)	3.3
N/A	Flare Type LT	N/A	N/A	Flare Type RT	N/A
N/A	Flare Slope LT (%)	N/A	N/A	Flare Slope RT (%)	N/A
N/A	Flare Traversable LT?	N/A	N/A	Flare Traversable RT?	N/A
N/A	Landing Length (in)	N/A	N/A	DWS Provided?	N/A
N/A	Landing Width (in)	N/A	N/A	DWS Contrast?	N/A
N/A	Landing Slope (%)	N/A	N/A	DWS Length (in)	N/A
N/A	Landing X Slope (%)	N/A	N/A	DWS Full Width?	N/A
N/A	Landing Curb? (Y/N)	N/A	N/A	DWS Offset (in)	N/A
N/A	Shared Landing?	N/A			
N/A	Gutter Ponding?	N/A	N/A	Gutter Slope (%)	N/A
N/A	Gutter Lip Ht (in)	N/A	N/A	Gutter X Slope (%)	N/A
N/A	Painted X Walk1?	No	N/A	Painted X Walk2?	N/A
	X Walk 1 Direction	To E		X Walk 2 Direction	N/A
N/A	X Walk 1 Width (in)	N/A	N/A	X Walk 2 Width (in)	N/A
	X Walk 1 Slope (%)	7.2		X Walk 2 Slope (%)	N/A
	X Walk 1 X Slope (%)	3.8		X Walk 2 X Slope (%)	N/A

N/A	Ramp inside XWalk1?	N/A	N/A	Ramp inside XWalk2?	N/A
	Road Slope (%)	3.8	N/A	Clear Space?	N/A
	Road X Slope (%)	7.2	N/A	Clear Space to XWalk (in)	N/A
N/A	Any Obstructions?	N/A	N/A	Storm Grate/Utility Hazard?	N/A
	Obstruction Type			Storm Grate/Utility Type	
		N/A			N/A
			Yes	Surface Condition? (G/P)	Good

**Remove & Replace Entire Ramp.**
