Access Compliance Report

Public Rights-of-Way

(Curb Ramps)

Intersection ID: 7091	Main Street: BROOKSHIRE_BV	Cross Street: HOVIS_RD	Location:	E
ADA ID: B52023F0A38F	Ramp Type: Perp	Initial Pass/Fail: Fail	Overall Compliance: No	Severity Score: 8.75

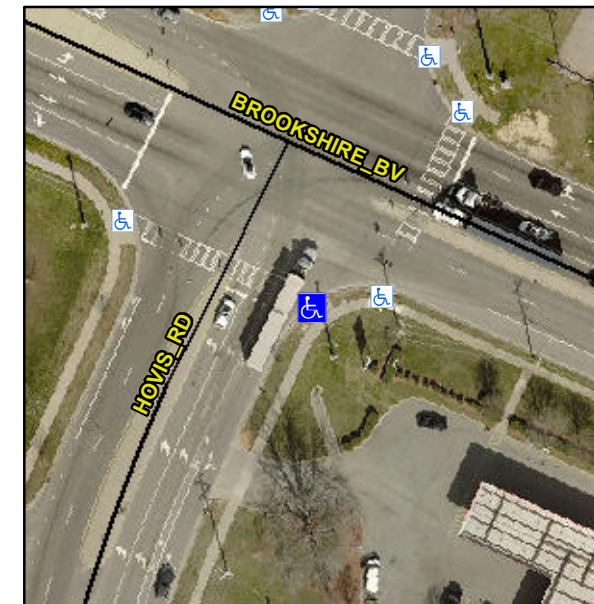
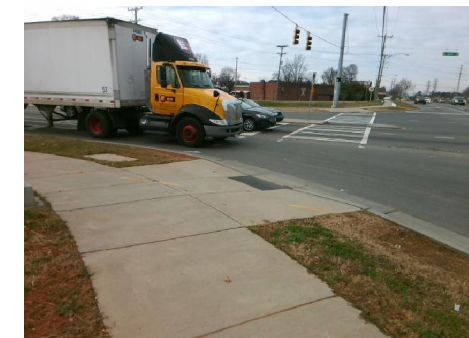
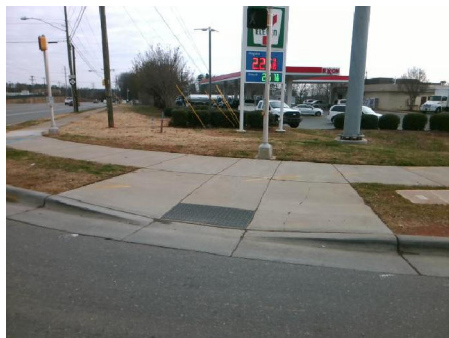
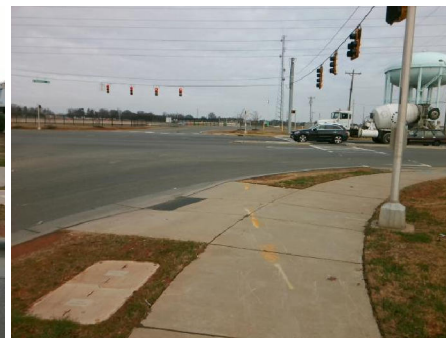
Compliance	Description	Data	Compliance	Description	Data
N/A	Ramp Length (in)	87.0	Yes	Ramp Slope (%)	8.0
No	Ramp Width (in)	42.5	Yes	Ramp XSlope (%)	2.0
N/A	Flare Type LT	N/A	N/A	Flare Type RT	N/A
N/A	Flare Slope LT (%)	N/A	N/A	Flare Slope RT (%)	N/A
N/A	Flare Traversable LT?	N/A	N/A	Flare Traversable RT?	N/A
N/A	Landing Length (in)	N/A	N/A	DWS Provided?	N/A
N/A	Landing Width (in)	N/A	N/A	DWS Contrast?	N/A
N/A	Landing Slope (%)	N/A	N/A	DWS Length (in)	N/A
N/A	Landing X Slope (%)	N/A	N/A	DWS Full Width?	N/A
N/A	Landing Curb? (Y/N)	N/A	N/A	DWS Offset (in)	N/A
N/A	Shared Landing?	N/A			
N/A	Gutter Ponding?	N/A	N/A	Gutter Slope (%)	N/A
N/A	Gutter Lip Ht (in)	N/A	N/A	Gutter X Slope (%)	N/A
N/A	Painted X Walk1?	No	N/A	Painted X Walk2?	N/A
	X Walk 1 Direction	To NW		X Walk 2 Direction	N/A
N/A	X Walk 1 Width (in)	N/A	N/A	X Walk 2 Width (in)	N/A
	X Walk 1 Slope (%)	0.3		X Walk 2 Slope (%)	N/A
	X Walk 1 X Slope (%)	1.2		X Walk 2 X Slope (%)	N/A

N/A	Ramp inside XWalk1?	N/A	N/A	Ramp inside XWalk2?	N/A
	Road Slope (%)	N/A	N/A	Clear Space?	N/A
	Road X Slope (%)	N/A	N/A	Clear Space to XWalk (in)	N/A
N/A	Any Obstructions?	N/A	N/A	Storm Grate/Utility Hazard?	N/A
	Obstruction Type			Storm Grate/Utility Type	
		N/A			N/A
			Yes	Surface Condition? (G/P)	Good

Remove & Replace Entire Ramp.
