Access Compliance Report

Public Rights-of-Way (Curb Ramps)

Intersection ID: 42521	Main Street: I-485_RA	Cross Street: PROVIDENCE_RD	Location: SW
ADA ID: B521A5E1669C	Ramp Type: PerpDiag	Initial Pass/Fail: Fail	Overall Compliance: No
		Severity Score: 22.5

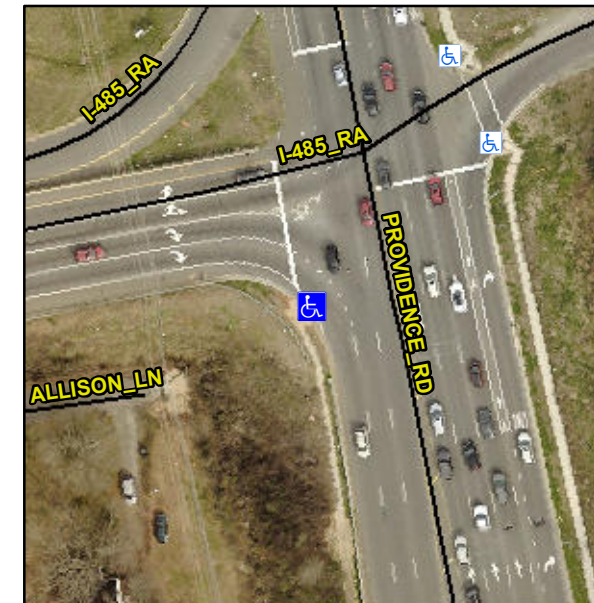
Not Found, R304.5.1, R304.2.2

Compliance	Description	Data	Compliance	Description	Data
N/A	Ramp Length (in)	48.0	No	Ramp Slope (%)	9.3
No	Ramp Width (in)	47.0	Yes	Ramp XSlope (%)	4.1
N/A	Flare Type LT	N/A	N/A	Flare Type RT	N/A
N/A	Flare Slope LT (%)	N/A	N/A	Flare Slope RT (%)	N/A
N/A	Flare Traversable LT?	N/A	N/A	Flare Traversable RT?	N/A
N/A	Landing Length (in)	N/A	N/A	DWS Provided?	N/A
N/A	Landing Width (in)	N/A	N/A	DWS Contrast?	N/A
N/A	Landing Slope (%)	N/A	N/A	DWS Length (in)	N/A
N/A	Landing X Slope (%)	N/A	N/A	DWS Full Width?	N/A
N/A	Landing Curb? (Y/N)	N/A	N/A	DWS Offset (in)	N/A
N/A	Shared Landing?	N/A			
N/A	Gutter Ponding?	N/A	N/A	Gutter Slope (%)	N/A
N/A	Gutter Lip Ht (in)	N/A	N/A	Gutter X Slope (%)	N/A
N/A	Painted X Walk1?	No	N/A	Painted X Walk2?	No
	X Walk 1 Direction	To E		X Walk 2 Direction	To N
N/A	X Walk 1 Width (in)	N/A	N/A	X Walk 2 Width (in)	N/A
	X Walk 1 Slope (%)	5.3		X Walk 2 Slope (%)	7.9
	X Walk 1 X Slope (%)	3.9		X Walk 2 X Slope (%)	3.8

N/A	Ramp inside XWalk1?	N/A	N/A	Ramp inside XWalk2?	N/A
	Road Slope (%)	4.1	N/A	Clear Space?	N/A
	Road X Slope (%)	6.1	N/A	Clear Space to XWalk (in)	N/A
N/A	Any Obstructions?	N/A	N/A	Storm Grate/Utility Hazard?	N/A
	Obstruction Type			Storm Grate/Utility Type	
		N/A			N/A
			Yes	Surface Condition? (G/P)	Good

Remove & Replace Curb Ramp With Two New Directional Ramps or Equivalent.
