Access Compliance Report

Public Rights-of-Way

(Curb Ramps)

Intersection ID: 47977	Main Street: AVALY_LN	Cross Street: SPRINGS_MILL_RD	Location: SW
ADA ID: B52542E52158	Ramp Type: BlendTrans1	Initial Pass/Fail: Fail	Overall Compliance: No
Severity Score: 8.75			
Codes/Mitigation Info/Possible Solution		Field Measurements/Component Compliance

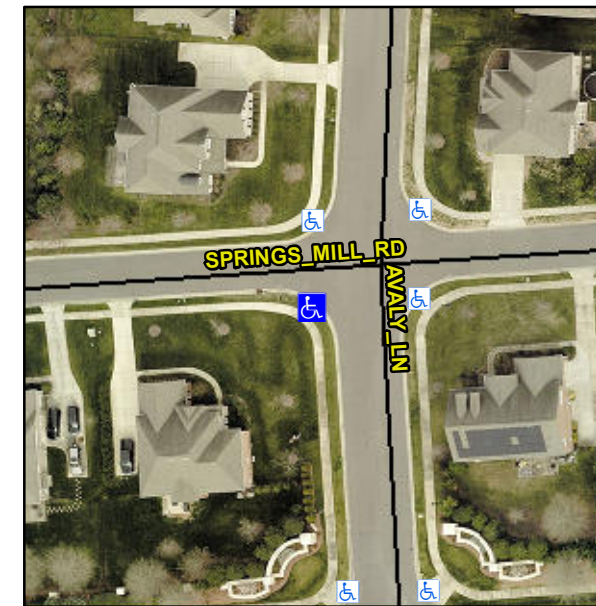
Not Found, R304.5.1

Compliance	Description	Data	Compliance	Description	Data
N/A	Ramp Length (in)	78.0	Yes	BlendTrans Slope (%)	4.1
No	Ramp Width (in)	44.0	Yes	BlendTrans XSlope (%)	2.0
N/A	Flare Type LT	N/A	N/A	Flare Type RT	N/A
N/A	Flare Slope LT (%)	N/A	N/A	Flare Slope RT (%)	N/A
N/A	Flare Traversable LT?	N/A	N/A	Flare Traversable RT?	N/A
N/A	Landing Length (in)	N/A	N/A	DWS Provided?	N/A
N/A	Landing Width (in)	N/A	N/A	DWS Contrast?	N/A
N/A	Landing Slope (%)	N/A	N/A	DWS Length (in)	N/A
N/A	Landing X Slope (%)	N/A	N/A	DWS Full Width?	N/A
N/A	Landing Curb? (Y/N)	N/A	N/A	DWS Offset (in)	N/A
N/A	Shared Landing?	N/A			
N/A	Gutter Ponding?	N/A	N/A	Gutter Slope (%)	N/A
N/A	Gutter Lip Ht (in)	N/A	N/A	Gutter X Slope (%)	N/A
N/A	Painted X Walk1?	No	N/A	Painted X Walk2?	No
	X Walk 1 Direction	To E		X Walk 2 Direction	To N
	X Walk 1 Width (in)	N/A		X Walk 2 Width (in)	N/A
	X Walk 1 Slope (%)	2.7		X Walk 2 Slope (%)	0.9
	X Walk 1 X Slope (%)	0.4		X Walk 2 X Slope (%)	3.4

N/A	Ramp inside XWalk1?	N/A	N/A	Ramp inside XWalk2?	N/A
	Road Slope (%)	3.1		Clear Space?	N/A
	Road X Slope (%)	2.7	N/A	Clear Space to XWalk (in)	N/A
N/A	Any Obstructions?	N/A	N/A	Storm Grate/Utility Hazard?	N/A
	Obstruction Type			Storm Grate/Utility Type	
		N/A			N/A
			Yes	Surface Condition? (G/P)	Good
			No	Curb Slope (%)	7.9

Remove & Replace Curb Ramp With Two New Directional Ramps or Equivalent.
