# Access Compliance Report

## Public Rights-of-Way

### (Curb Ramps)

Intersection ID: 9448	Main Street: DELTA_LAKE_DR	Cross Street: E_W_T_HARRIS_BV	Location: SW
ADA ID: B52746A9B6C1	Ramp Type: PerpDiag	Initial Pass/Fail: Fail	Overall Compliance: No
		Severity Score: 12.5

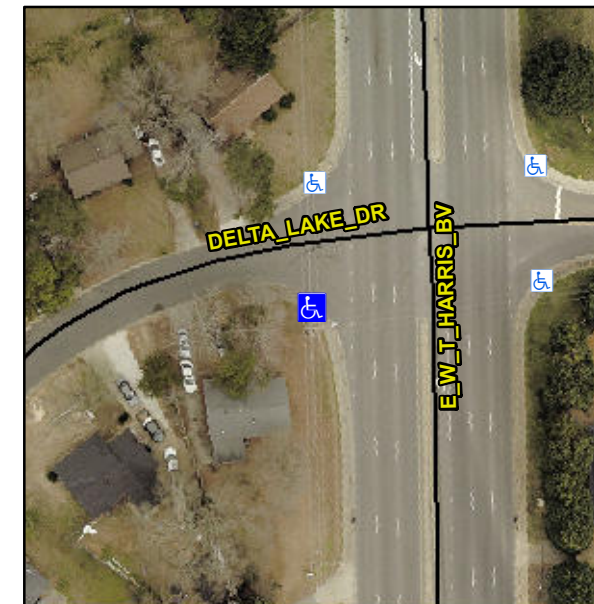
**Not Found, R304.2.2**

Compliance	Description	Data	Compliance	Description	Data
N/A	Ramp Length (in)	59.5	No	Ramp Slope (%)	9.6
Yes	Ramp Width (in)	48.0	Yes	Ramp XSlope (%)	1.1
N/A	Flare Type LT	N/A	N/A	Flare Type RT	N/A
N/A	Flare Slope LT (%)	N/A	N/A	Flare Slope RT (%)	N/A
N/A	Flare Traversable LT?	N/A	N/A	Flare Traversable RT?	N/A
N/A	Landing Length (in)	N/A	N/A	DWS Provided?	N/A
N/A	Landing Width (in)	N/A	N/A	DWS Contrast?	N/A
N/A	Landing Slope (%)	N/A	N/A	DWS Length (in)	N/A
N/A	Landing X Slope (%)	N/A	N/A	DWS Full Width?	N/A
N/A	Landing Curb? (Y/N)	N/A	N/A	DWS Offset (in)	N/A
N/A	Shared Landing?	N/A			
N/A	Gutter Ponding?	N/A	N/A	Gutter Slope (%)	N/A
N/A	Gutter Lip Ht (in)	N/A	N/A	Gutter X Slope (%)	N/A
N/A	Painted X Walk1?	No	N/A	Painted X Walk2?	No
	X Walk 1 Direction	To E		X Walk 2 Direction	To N
N/A	X Walk 1 Width (in)	N/A	N/A	X Walk 2 Width (in)	N/A
	X Walk 1 Slope (%)	2.2		X Walk 2 Slope (%)	0.7
	X Walk 1 X Slope (%)	0.6		X Walk 2 X Slope (%)	3.9

N/A	Ramp inside XWalk1?	N/A	N/A	Ramp inside XWalk2?	N/A
	Road Slope (%)	2.6	N/A	Clear Space?	N/A
	Road X Slope (%)	6.1	N/A	Clear Space to XWalk (in)	N/A
N/A	Any Obstructions?	N/A	N/A	Storm Grate/Utility Hazard?	N/A
	Obstruction Type			Storm Grate/Utility Type	
		N/A			N/A
			Yes	Surface Condition? (G/P)	Good

**Remove & Replace Curb Ramp With Two New Directional Ramps or Equivalent.**
