Access Compliance Report

Public Rights-of-Way

(Curb Ramps)

Intersection ID: 10123	Main Street: GLENWOOD_DR	Cross Street: TUCKASEEGEE_RD	Location: S
ADA ID: B52B07960C3A	Ramp Type: Perp	Initial Pass/Fail: Fail	Overall Compliance: No
		Severity Score: 8.75

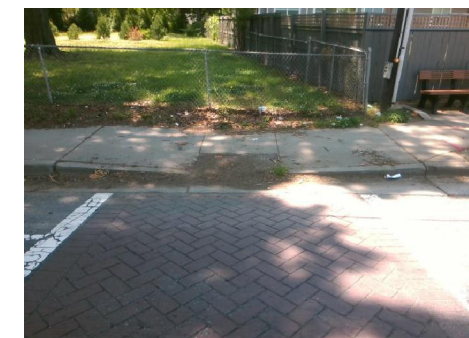
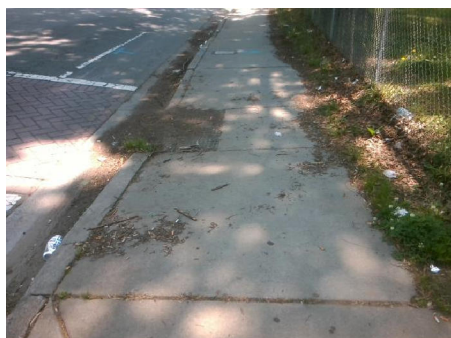
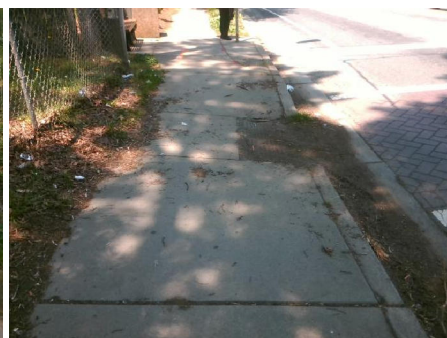
Compliance	Description	Data	Compliance	Description	Data
N/A	Ramp Length (in)	70.0	Yes	Ramp Slope (%)	5.9
No	Ramp Width (in)	47.5	Yes	Ramp XSlope (%)	0.2
N/A	Flare Type LT	N/A	N/A	Flare Type RT	N/A
N/A	Flare Slope LT (%)	N/A	N/A	Flare Slope RT (%)	N/A
N/A	Flare Traversable LT?	N/A	N/A	Flare Traversable RT?	N/A
N/A	Landing Length (in)	N/A	N/A	DWS Provided?	N/A
N/A	Landing Width (in)	N/A	N/A	DWS Contrast?	N/A
N/A	Landing Slope (%)	N/A	N/A	DWS Length (in)	N/A
N/A	Landing X Slope (%)	N/A	N/A	DWS Full Width?	N/A
N/A	Landing Curb? (Y/N)	N/A	N/A	DWS Offset (in)	N/A
N/A	Shared Landing?	N/A			
N/A	Gutter Ponding?	Yes	N/A	Gutter Slope (%)	N/A
N/A	Gutter Lip Ht (in)	N/A	N/A	Gutter X Slope (%)	N/A
N/A	Painted X Walk1?	Yes	N/A	Painted X Walk2?	N/A
	X Walk 1 Direction	To N		X Walk 2 Direction	N/A
N/A	X Walk 1 Width (in)	114.0	N/A	X Walk 2 Width (in)	N/A
	X Walk 1 Slope (%)	11.4		X Walk 2 Slope (%)	N/A
	X Walk 1 X Slope (%)	0.3		X Walk 2 X Slope (%)	N/A

N/A	Ramp inside XWalk1?	Yes	N/A	Ramp inside XWalk2?	N/A
	Road Slope (%)	N/A	N/A	Clear Space?	N/A
	Road X Slope (%)	N/A	N/A	Clear Space to XWalk (in)	N/A
N/A	Any Obstructions?	N/A	N/A	Storm Grate/Utility Hazard?	N/A
	Obstruction Type			Storm Grate/Utility Type	
		N/A			N/A
			Yes	Surface Condition? (G/P)	Good

Possible Solutions:

Remove & Replace Entire Ramp.

Not Found, R304.5.1
