# Access Compliance Report

## Public Rights-of-Way

### (Curb Ramps)

| Intersection ID: 16671 | Main Street: RANDOLPH_RD | Cross Street: WENDWOOD_LN | Location: SE |

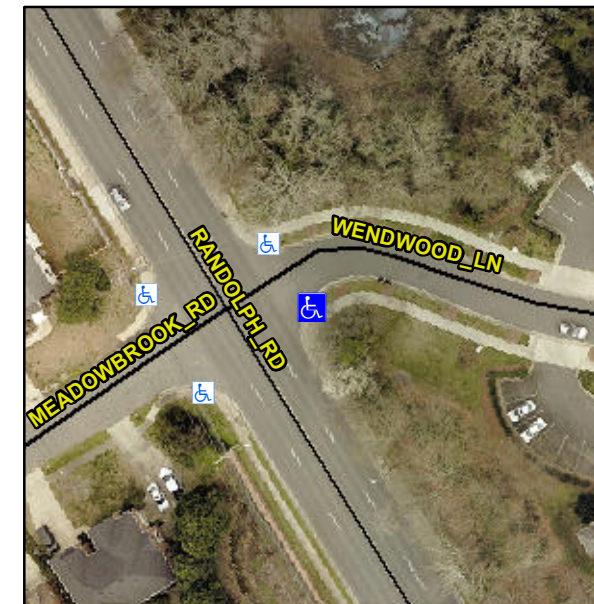
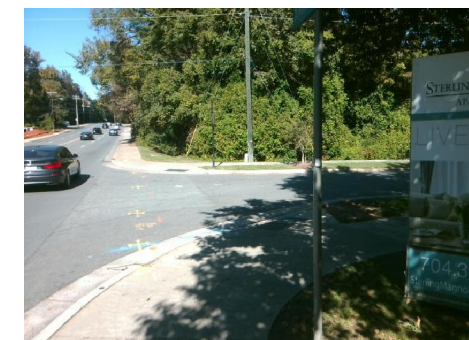
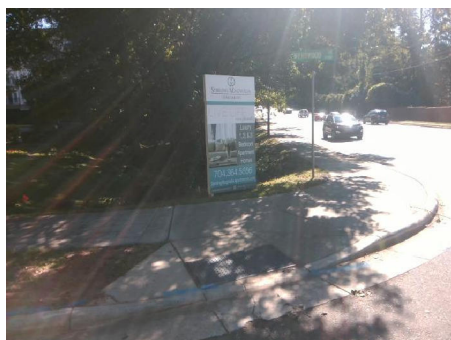
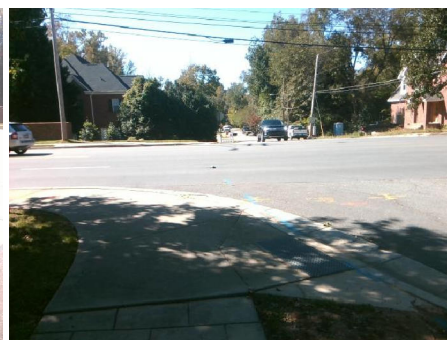
| ADA ID: B53810FEDA35 | Ramp Type: PerpDiag | Initial Pass/Fail: Fail | Overall Compliance: No |

**R304.5.1, R304.2.2, R304.5.3**

| Compliance | Description | Data | Compliance | Description | Data |
|---|---|---|---|---|---|
| N/A | Ramp Length (in) | 76.0 | No | Ramp Slope (%) | 8.6 |
| No | Ramp Width (in) | 45.5 | No | Ramp XSlope (%) | 3.1 |

**Remove & Replace Curb Ramp With Two New Directional Ramps or Equivalent.**
