Intersection ID: 14952	Main Street: REGAL_OAKS_DR	Cross Street: WINDING_CEDAR_TL	Location:	NW
ADA ID: B53D5A3A336D	Ramp Type: Para	Initial Pass/Fail: Pass	Overall Compliance: No	Severity Score: 0.25

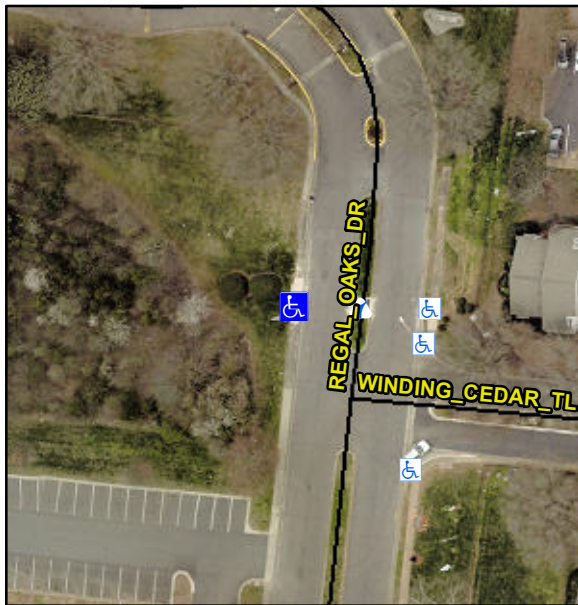
Compliance	Description	Data	Compliance	Description	Data
N/A	Ramp Length LT (in)	70.0	N/A	Ramp Length RT (in)	65.0
Yes	Ramp Width LT (in)	60.0	Yes	Ramp Width RT (in)	59.0
Yes	Ramp Slope LT (%)	5.7	Yes	Ramp Slope RT (%)	7.8
Yes	Ramp XSlope LT (%)	0.1	No	Ramp XSlope RT (%)	2.6
No	Landing Length (in)	58.0	Yes	DWS Provided?	Yes
Yes	Landing Width (in)	60.0	Yes	DWS Contrast?	Yes
No	Landing Slope (%)	4.6	Yes	DWS Length (in)	24.0
Yes	Landing X Slope (%)	1.9	Yes	DWS Full Width?	Yes
N/A	Landing Curb? (Y/N)	Yes	Yes	DWS Offset (in)	2.0
N/A	Shared Landing?	No			
Yes	Gutter Ponding?	No	Yes	Gutter Slope (%)	2.7
Yes	Gutter Lip Ht (in)	0.0	Yes	Gutter X Slope (%)	1.6
N/A	Painted X Walk1?	No	N/A	Painted X Walk2?	N/A
	X Walk 1 Direction	To E		X Walk 2 Direction	N/A
N/A	X Walk 1 Width (in)	N/A	N/A	X Walk 2 Width (in)	N/A
	X Walk 1 Slope (%)	2.1		X Walk 2 Slope (%)	N/A
	X Walk 1 X Slope (%)	1.7		X Walk 2 X Slope (%)	N/A
N/A	Ramp inside XWalk1?	N/A	N/A	Ramp inside XWalk2?	N/A

Road Slope (%)	N/A	N/A	Clear Space?	Yes
	Road X Slope (%)	N/A	N/A	Clear Space to XWalk (in)	N/A
Yes	Any Obstructions?	No	Yes	Storm Grate/Utility Hazard?	No
	Obstruction Type			Storm Grate/Utility Type	
		N/A			N/A
			Yes	Surface Condition? (G/P)	Good
			N/A	Curb Slope (%)	2.8

Possible Solutions:

Remove & Replace Entire Ramp.
