Access Compliance Report Public Rights-of-Way (Curb Ramps)

Intersection ID: 12377 Main Street: S TRYON ST Cross Street: E 4TH ST Location: S Initial Pass/Fail: Pass **Overall Compliance: No Severity Score:** 7.5

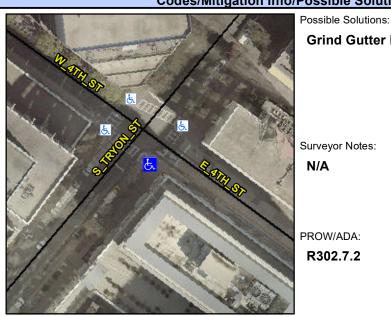
Gutter Lip Ht (in) 0.5 Yes Gutter X Slope (%) Painted X Walk1? Yes N/A Painted X Walk2? X Walk 1 Direction To NE X Walk 2 Direction To NW 109.0 N/A X Walk 1 Width (in) X Walk 2 Width (in) X Walk 1 Slope (%) 1.7 X Walk 2 Slope (%) X Walk 1 X Slope (%) 1.4 X Walk 2 X Slope (%) Yes Ramp inside XWalk2? Ramp inside XWalk1? Yes Road Slope (%) 0.5 N/A Clear Space? Road X Slope (%) 1.7 Yes Clear Space to XWalk (in) No Yes Any Obstructions? Yes Storm Grate/Utility Hazard? **Obstruction Type** Storm Grate/Utility Type N/A Yes Surface Condition? (G/P)

Grind Gutter Lip.
