Access Compliance Report

Public Rights-of-Way

(Curb Ramps)

Intersection ID: 48024	Main Street: LADLEY_CT	Cross Street: OLD_PROVIDENCE_RD	Location: S
ADA ID: B5447C754683	Ramp Type: PerpDiag	Initial Pass/Fail: Fail	Overall Compliance: No
		Severity Score: 22.5

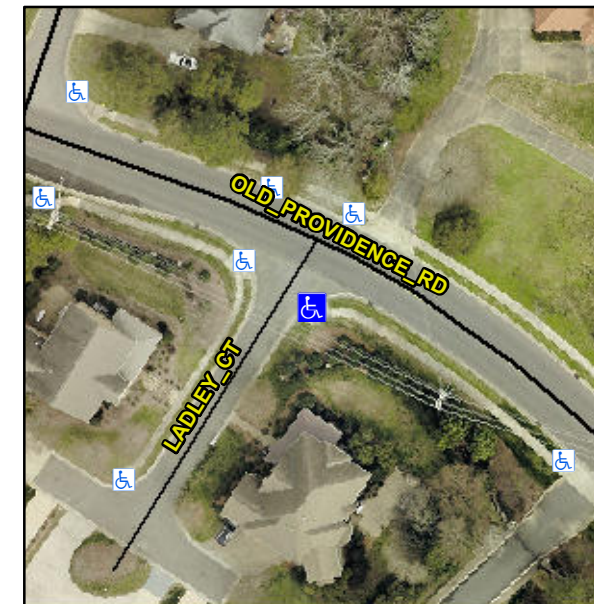
Compliance	Description	Data	Compliance	Description	Data
N/A	Ramp Length (in)	58.0	No	Ramp Slope (%)	9.7
No	Ramp Width (in)	47.0	No	Ramp XSlope (%)	2.9
N/A	Flare Type LT	N/A	N/A	Flare Type RT	N/A
N/A	Flare Slope LT (%)	N/A	N/A	Flare Slope RT (%)	N/A
N/A	Flare Traversable LT?	N/A	N/A	Flare Traversable RT?	N/A
N/A	Landing Length (in)	N/A	N/A	DWS Provided?	N/A
N/A	Landing Width (in)	N/A	N/A	DWS Contrast?	N/A
N/A	Landing Slope (%)	N/A	N/A	DWS Length (in)	N/A
N/A	Landing X Slope (%)	N/A	N/A	DWS Full Width?	N/A
N/A	Landing Curb? (Y/N)	N/A	N/A	DWS Offset (in)	N/A
N/A	Shared Landing?	N/A			
N/A	Gutter Ponding?	N/A	N/A	Gutter Slope (%)	N/A
N/A	Gutter Lip Ht (in)	N/A	N/A	Gutter X Slope (%)	N/A
N/A	Painted X Walk1?	No	N/A	Painted X Walk2?	No
	X Walk 1 Direction	To NE		X Walk 2 Direction	To NW
N/A	X Walk 1 Width (in)	N/A	N/A	X Walk 2 Width (in)	N/A
	X Walk 1 Slope (%)	4.3		X Walk 2 Slope (%)	2.1
	X Walk 1 X Slope (%)	2.0		X Walk 2 X Slope (%)	3.1

N/A	Ramp inside XWalk1?	N/A	N/A	Ramp inside XWalk2?	N/A
	Road Slope (%)	4.0	N/A	Clear Space?	N/A
	Road X Slope (%)	5.0	N/A	Clear Space to XWalk (in)	N/A
N/A	Any Obstructions?	N/A	N/A	Storm Grate/Utility Hazard?	N/A
	Obstruction Type			Storm Grate/Utility Type	
		N/A			N/A
			Yes	Surface Condition? (G/P)	Good

Possible Solutions:

Remove & Replace Curb Ramp With Two New Directional Ramps or Equivalent.

Not Found, R304.5.1, R304.2.2, R304.5.3
