Access Compliance Report

Public Rights-of-Way

(Curb Ramps)

Intersection ID: 20018	Main Street: PARK_RD	Cross Street: FAIRVIEW_RD	Location: NE
ADA ID: B54A0F9E4795	Ramp Type: Perp	Initial Pass/Fail: Fail	Overall Compliance: No
Severity Score: 37.5			
Codes/Mitigation Info/Possible Solution		Field Measurements/Component Compliance

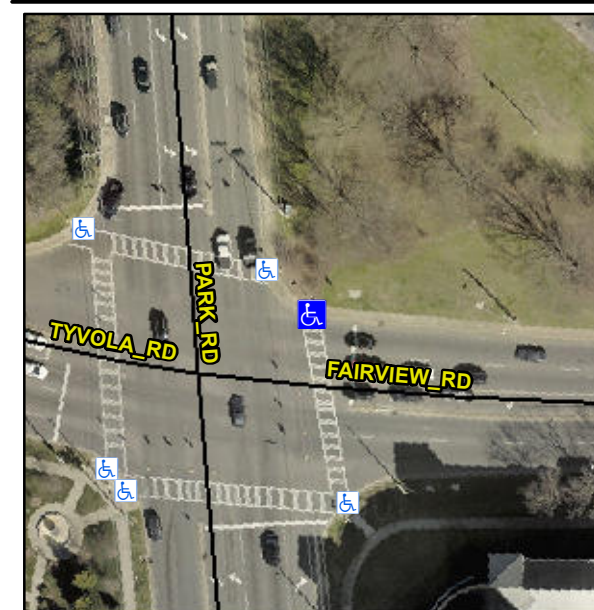
R304.2.2, R304.5.3

Compliance	Description	Data	Compliance	Description	Data
N/A	Ramp Length (in)	63.0	No	Ramp Slope (%)	9.1
Yes	Ramp Width (in)	48.0	No	Ramp XSlope (%)	9.2
N/A	Flare Type LT	N/A	N/A	Flare Type RT	N/A
N/A	Flare Slope LT (%)	N/A	N/A	Flare Slope RT (%)	N/A
N/A	Flare Traversable LT?	N/A	N/A	Flare Traversable RT?	N/A
N/A	Landing Length (in)	N/A	N/A	DWS Provided?	N/A
N/A	Landing Width (in)	N/A	N/A	DWS Contrast?	N/A
N/A	Landing Slope (%)	N/A	N/A	DWS Length (in)	N/A
N/A	Landing X Slope (%)	N/A	N/A	DWS Full Width?	N/A
N/A	Landing Curb? (Y/N)	N/A	N/A	DWS Offset (in)	N/A
N/A	Shared Landing?	N/A			
N/A	Gutter Ponding?	N/A	N/A	Gutter Slope (%)	N/A
N/A	Gutter Lip Ht (in)	N/A	N/A	Gutter X Slope (%)	N/A
N/A	Painted X Walk1?	Yes	N/A	Painted X Walk2?	N/A
	X Walk 1 Direction	To S		X Walk 2 Direction	N/A
N/A	X Walk 1 Width (in)	110.0	N/A	X Walk 2 Width (in)	N/A
	X Walk 1 Slope (%)	3.9		X Walk 2 Slope (%)	N/A
	X Walk 1 X Slope (%)	3.7		X Walk 2 X Slope (%)	N/A

N/A	Ramp inside XWalk1?	Yes	N/A	Ramp inside XWalk2?	N/A
	Road Slope (%)	N/A	N/A	Clear Space?	N/A
	Road X Slope (%)	N/A	N/A	Clear Space to XWalk (in)	N/A
N/A	Any Obstructions?	N/A	N/A	Storm Grate/Utility Hazard?	N/A
	Obstruction Type			Storm Grate/Utility Type	
		N/A			N/A
			Yes	Surface Condition? (G/P)	Good

Possible Solutions:

Remove & Replace Entire Ramp.
