Access Compliance Report

Public Rights-of-Way

(Curb Ramps)

Intersection ID: 31601	Main Street: BULL_RUN_RD	Cross Street: GETALONG_RD	Location: NE
ADA ID: B54C87AFB38A	Ramp Type: BlendTrans1	Initial Pass/Fail: Fail	Overall Compliance: No
		Severity Score: 1.25

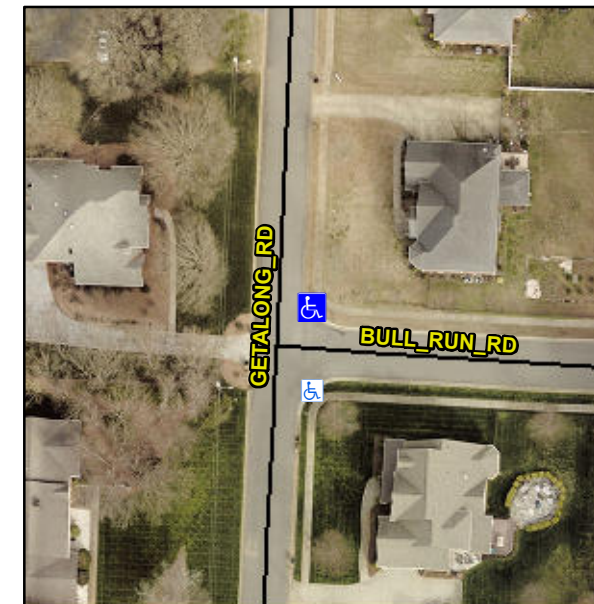
Not Found, R304.5.3

Compliance	Description	Data	Compliance	Description	Data
N/A	Ramp Length (in)	67.0	Yes	BlendTrans Slope (%)	1.9
Yes	Ramp Width (in)	48.0	No	BlendTrans XSlope (%)	4.5
N/A	Flare Type LT	N/A	N/A	Flare Type RT	N/A
N/A	Flare Slope LT (%)	N/A	N/A	Flare Slope RT (%)	N/A
N/A	Flare Traversable LT?	N/A	N/A	Flare Traversable RT?	N/A
N/A	Landing Length (in)	N/A	N/A	DWS Provided?	N/A
N/A	Landing Width (in)	N/A	N/A	DWS Contrast?	N/A
N/A	Landing Slope (%)	N/A	N/A	DWS Length (in)	N/A
N/A	Landing X Slope (%)	N/A	N/A	DWS Full Width?	N/A
N/A	Landing Curb? (Y/N)	N/A	N/A	DWS Offset (in)	N/A
N/A	Shared Landing?	N/A			
N/A	Gutter Ponding?	N/A	N/A	Gutter Slope (%)	N/A
N/A	Gutter Lip Ht (in)	N/A	N/A	Gutter X Slope (%)	N/A
N/A	Painted X Walk1?	No	N/A	Painted X Walk2?	N/A
	X Walk 1 Direction	To S		X Walk 2 Direction	N/A
	X Walk 1 Width (in)	N/A		X Walk 2 Width (in)	N/A
	X Walk 1 Slope (%)	0.4		X Walk 2 Slope (%)	N/A
	X Walk 1 X Slope (%)	2.8		X Walk 2 X Slope (%)	N/A

N/A	Ramp inside XWalk1?	N/A	N/A	Ramp inside XWalk2?	N/A
	Road Slope (%)	2.8		Clear Space?	N/A
	Road X Slope (%)	0.4	N/A	Clear Space to XWalk (in)	N/A
N/A	Any Obstructions?	N/A	N/A	Storm Grate/Utility Hazard?	N/A
	Obstruction Type			Storm Grate/Utility Type	
		N/A			N/A
			Yes	Surface Condition? (G/P)	Good
			No	Curb Slope (%)	10.7

Remove & Replace Curb Ramp With Two New Directional Ramps or Equivalent.
