Access Compliance Report

Public Rights-of-Way

(Curb Ramps)

Intersection ID: 21934	Main Street: SHARON_RD	Cross Street: CHANDWORTH_RD	Location: W
ADA ID: B550B1F865C2	Ramp Type: BlendTrans2	Initial Pass/Fail: Fail	Overall Compliance: No
Severity Score: 21.25			
Codes/Mitigation Info/Possible Solution		Field Measurements/Component Compliance

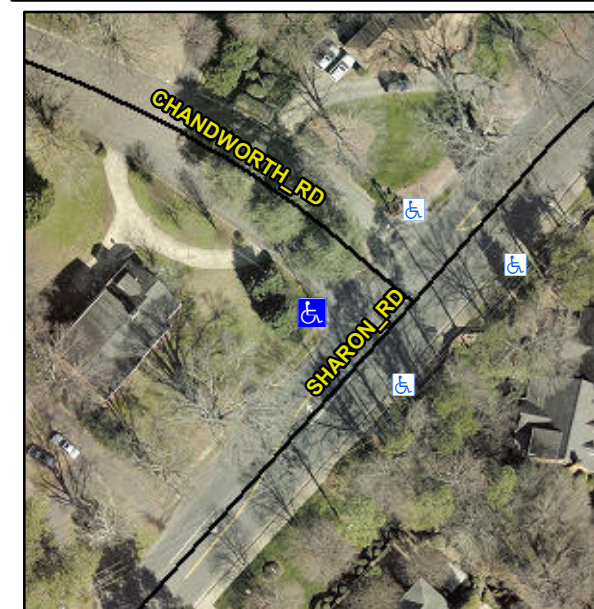
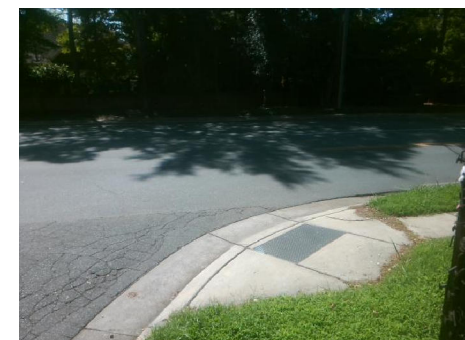
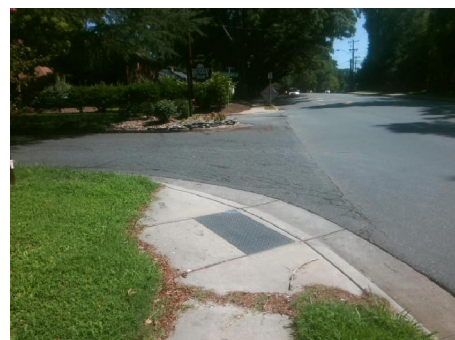
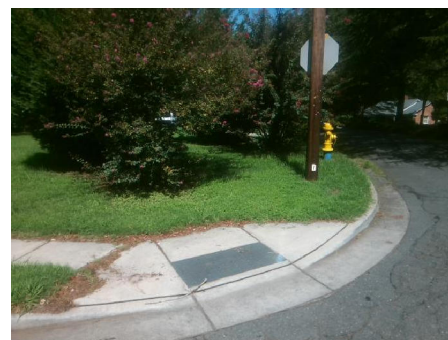
R304.5.1, R304.5.3

Compliance	Description	Data	Compliance	Description	Data
N/A	Ramp Length (in)	64.0	Yes	BlendTrans Slope (%)	3.8
No	Ramp Width (in)	47.0	No	BlendTrans XSlope (%)	5.3
N/A	Flare Type LT	N/A	N/A	Flare Type RT	N/A
N/A	Flare Slope LT (%)	N/A	N/A	Flare Slope RT (%)	N/A
N/A	Flare Traversable LT?	N/A	N/A	Flare Traversable RT?	N/A
N/A	Landing Length (in)	N/A	N/A	DWS Provided?	N/A
N/A	Landing Width (in)	N/A	N/A	DWS Contrast?	N/A
N/A	Landing Slope (%)	N/A	N/A	DWS Length (in)	N/A
N/A	Landing X Slope (%)	N/A	N/A	DWS Full Width?	N/A
N/A	Landing Curb? (Y/N)	N/A	N/A	DWS Offset (in)	N/A
N/A	Shared Landing?	N/A			
N/A	Gutter Ponding?	N/A	N/A	Gutter Slope (%)	N/A
N/A	Gutter Lip Ht (in)	N/A	N/A	Gutter X Slope (%)	N/A
N/A	Painted X Walk1?	No	N/A	Painted X Walk2?	No
	X Walk 1 Direction	To SE		X Walk 2 Direction	To NE
	X Walk 1 Width (in)	N/A		X Walk 2 Width (in)	N/A
	X Walk 1 Slope (%)	2.8		X Walk 2 Slope (%)	3.4
	X Walk 1 X Slope (%)	2.5		X Walk 2 X Slope (%)	2.7

N/A	Ramp inside XWalk1?	N/A	N/A	Ramp inside XWalk2?	N/A
	Road Slope (%)	3.5		Clear Space?	N/A
	Road X Slope (%)	0.2	N/A	Clear Space to XWalk (in)	N/A
N/A	Any Obstructions?	N/A	N/A	Storm Grate/Utility Hazard?	N/A
	Obstruction Type			Storm Grate/Utility Type	
		N/A			N/A
			Yes	Surface Condition? (G/P)	Good
			N/A	Curb Slope (%)	2.1

Remove & Replace Curb Ramp With Two New Directional Ramps or Equivalent.
