Access Compliance Report Public Rights-of-Way (Curb Ramps)

Intersection ID: 29467 Main Street: GLEN_ROBIN_CT Cross Street: BROOKCHASE_LN Location: E

ADA ID: B55F80B8C671 Ramp Type: PerpDiag Initial Pass/Fail: Pass Overall Compliance: No Severity Score: 15

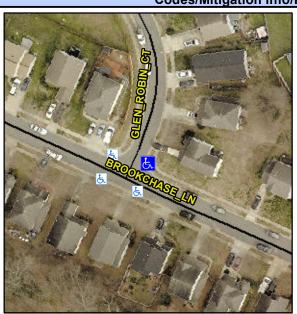
Not Found, R304.2.1, R305, R304.5.4

Field Measurements/Component Compliance					
Compliance Description		Data	Comp	oliance Description	Data
N/A	Ramp Length (in)	50.0	Yes	Ramp Slope (%)	5.5
Yes	Ramp Width (in)	48.0	Yes	Ramp XSlope (%)	0.9
N/A	Flare Type LT	Sloped	N/A	Flare Type RT	N/A
N/A	Flare Slope LT (%)	1.7	N/A	Flare Slope RT (%)	5.8
N/A	Flare Traversable LT?	No	N/A	Flare Traversable RT?	No
No	Landing Length (in)	47.5	No	DWS Provided?	No
Yes	Landing Width (in)	48.0	N/A	DWS Contrast?	No
Yes	Landing Slope (%)	0.2	N/A	DWS Length (in)	N/A
Yes	Landing X Slope (%)	0.3	N/A	DWS Full Width?	No
N/A	Landing Curb? (Y/N)	No	N/A	DWS Offset (in)	N/A
N/A	Shared Landing?	Yes			
Yes	Gutter Ponding?	No	No	Gutter Slope (%)	9.1
Yes	Gutter Lip Ht (in)	0.0	Yes	Gutter X Slope (%)	0.9
N/A	Painted X Walk1?	No	N/A	Painted X Walk2?	No
	X Walk 1 Direction	To NW		X Walk 2 Direction	To SW
N/A	X Walk 1 Width (in)	N/A	N/A	X Walk 2 Width (in)	N/A
	X Walk 1 Slope (%)	3.5		X Walk 2 Slope (%)	2.8

X Walk 1 X Slope (%)	2.6		X Walk 2 X Slope (%)	3.9
N/A	Ramp inside XWalk1?	N/A	N/A	Ramp inside XWalk2?	N/A
	Road Slope (%)	0.1	N/A	Clear Space?	Yes
	Road X Slope (%)	6.6	N/A	Clear Space to XWalk (in)	N/A
Yes	Any Obstructions?	No	Yes	Storm Grate/Utility Hazard?	No
	Obstruction Type			Storm Grate/Utility Type	
		N/A			N/A
			Yes	Surface Condition? (G/P)	Good

Remove & Replace Curb Ramp With Two New Directional Ramps or Equivalent. Remove & Replace Gutter.
