Access Compliance Report

Public Rights-of-Way

(Curb Ramps)

Intersection ID: 10014410	Main Street: CORAM_PL	Cross Street: N/A	Location: E
ADA ID: B5671BFD25D6	Ramp Type: Perp	Initial Pass/Fail: Fail	Overall Compliance: No
		Severity Score: 8.75	
Codes/Mitigation Info/Possible Solution		Field Measurements/Component Compliance

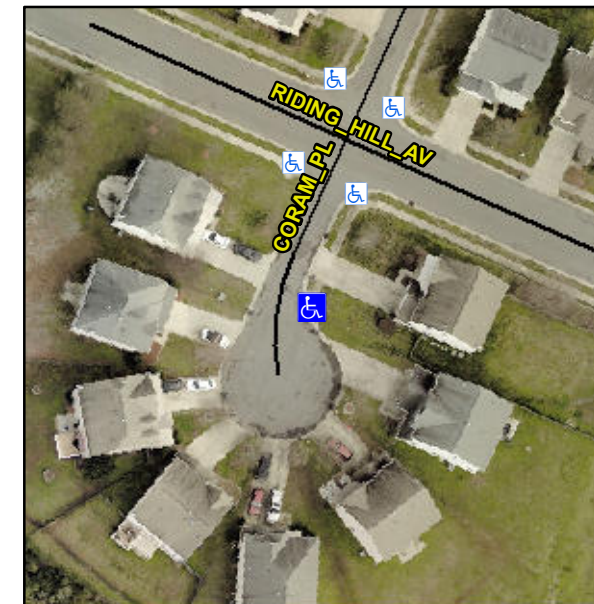
Not Found, R304.5.1

Compliance	Description	Data	Compliance	Description	Data
N/A	Ramp Length (in)	52.5	Yes	Ramp Slope (%)	5.6
No	Ramp Width (in)	46.0	Yes	Ramp XSlope (%)	0.3
N/A	Flare Type LT	N/A	N/A	Flare Type RT	N/A
N/A	Flare Slope LT (%)	N/A	N/A	Flare Slope RT (%)	N/A
N/A	Flare Traversable LT?	N/A	N/A	Flare Traversable RT?	N/A
N/A	Landing Length (in)	N/A	N/A	DWS Provided?	N/A
N/A	Landing Width (in)	N/A	N/A	DWS Contrast?	N/A
N/A	Landing Slope (%)	N/A	N/A	DWS Length (in)	N/A
N/A	Landing X Slope (%)	N/A	N/A	DWS Full Width?	N/A
N/A	Landing Curb? (Y/N)	N/A	N/A	DWS Offset (in)	N/A
N/A	Shared Landing?	N/A			
N/A	Gutter Ponding?	N/A	N/A	Gutter Slope (%)	N/A
N/A	Gutter Lip Ht (in)	N/A	N/A	Gutter X Slope (%)	N/A
N/A	Painted X Walk1?	No	N/A	Painted X Walk2?	N/A
	X Walk 1 Direction	To W		X Walk 2 Direction	N/A
N/A	X Walk 1 Width (in)	N/A	N/A	X Walk 2 Width (in)	N/A
	X Walk 1 Slope (%)	0.1		X Walk 2 Slope (%)	N/A
	X Walk 1 X Slope (%)	2.0		X Walk 2 X Slope (%)	N/A

N/A	Ramp inside XWalk1?	N/A	N/A	Ramp inside XWalk2?	N/A
	Road Slope (%)	N/A	N/A	Clear Space?	N/A
	Road X Slope (%)	N/A	N/A	Clear Space to XWalk (in)	N/A
N/A	Any Obstructions?	N/A	N/A	Storm Grate/Utility Hazard?	N/A
	Obstruction Type			Storm Grate/Utility Type	
		N/A			N/A
			Yes	Surface Condition? (G/P)	Good

Possible Solutions:

Remove & Replace Entire Ramp.
