# Access Compliance Report

## Public Rights-of-Way

### (Curb Ramps)

Intersection ID: 8549	Main Street: LASALLE_ST	Cross Street: NEWCASTLE_ST	Location: NW
ADA ID: B56BB50FC21C	Ramp Type: PerpDiag	Initial Pass/Fail: Fail	Overall Compliance: No
Severity Score: 22.5			
Codes/Mitigation Info/Possible Solution		Field Measurements/Component Compliance

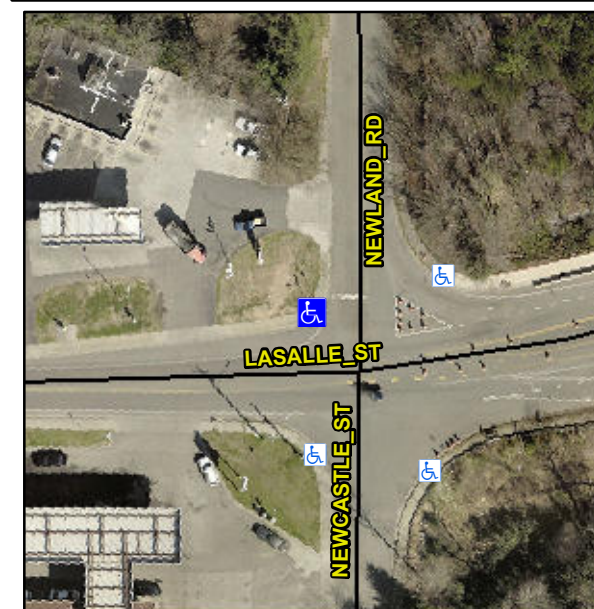
**Not Found, R304.5.1, R304.2.2, R304.5.3**

Compliance	Description	Data	Compliance	Description	Data
N/A	Ramp Length (in)	60.0	No	Ramp Slope (%)	9.0
No	Ramp Width (in)	40.0	No	Ramp XSlope (%)	2.7
N/A	Flare Type LT	N/A	N/A	Flare Type RT	N/A
N/A	Flare Slope LT (%)	N/A	N/A	Flare Slope RT (%)	N/A
N/A	Flare Traversable LT?	N/A	N/A	Flare Traversable RT?	N/A
N/A	Landing Length (in)	N/A	N/A	DWS Provided?	N/A
N/A	Landing Width (in)	N/A	N/A	DWS Contrast?	N/A
N/A	Landing Slope (%)	N/A	N/A	DWS Length (in)	N/A
N/A	Landing X Slope (%)	N/A	N/A	DWS Full Width?	N/A
N/A	Landing Curb? (Y/N)	N/A	N/A	DWS Offset (in)	N/A
N/A	Shared Landing?	N/A			
N/A	Gutter Ponding?	N/A	N/A	Gutter Slope (%)	N/A
N/A	Gutter Lip Ht (in)	N/A	N/A	Gutter X Slope (%)	N/A
N/A	Painted X Walk1?	No	N/A	Painted X Walk2?	No
	X Walk 1 Direction	To S		X Walk 2 Direction	To E
N/A	X Walk 1 Width (in)	N/A	N/A	X Walk 2 Width (in)	N/A
	X Walk 1 Slope (%)	5.3		X Walk 2 Slope (%)	0.4
	X Walk 1 X Slope (%)	0.8		X Walk 2 X Slope (%)	3.4

N/A	Ramp inside XWalk1?	N/A	N/A	Ramp inside XWalk2?	N/A
	Road Slope (%)	3.1	N/A	Clear Space?	N/A
	Road X Slope (%)	5.1	N/A	Clear Space to XWalk (in)	N/A
N/A	Any Obstructions?	N/A	N/A	Storm Grate/Utility Hazard?	N/A
	Obstruction Type			Storm Grate/Utility Type	
		N/A			N/A
		Yes		Surface Condition? (G/P)	Good

**Remove & Replace Curb Ramp With Two New Directional Ramps or Equivalent.**
