# Access Compliance Report

## Public Rights-of-Way

### (Curb Ramps)

Intersection ID: 12053	Main Street: GLENMAC_RD	Cross Street: TIGER_LILY_LN	Location: SW
ADA ID: B5741D7698E8	Ramp Type: Perp	Initial Pass/Fail: Fail	Overall Compliance: No
Severity Score: 17.5			
Codes/Mitigation Info/Possible Solution		Field Measurements/Component Compliance

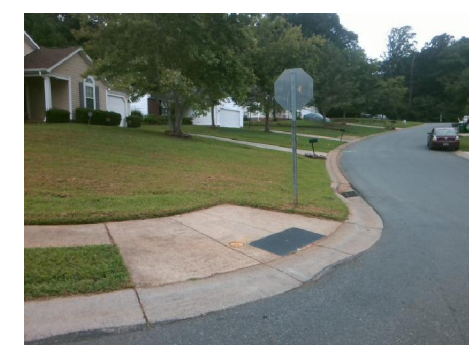
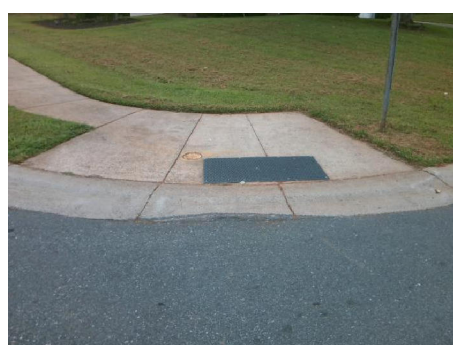
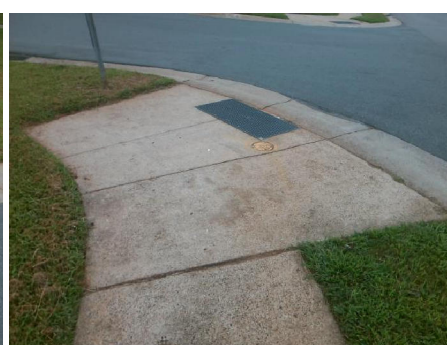
**Not Found, R304.5.1**

Compliance	Description	Data	Compliance	Description	Data
N/A	Ramp Length (in)	49.0	Yes	Ramp Slope (%)	7.3
No	Ramp Width (in)	34.0	Yes	Ramp XSlope (%)	0.4
N/A	Flare Type LT	N/A	N/A	Flare Type RT	N/A
N/A	Flare Slope LT (%)	N/A	N/A	Flare Slope RT (%)	N/A
N/A	Flare Traversable LT?	N/A	N/A	Flare Traversable RT?	N/A
N/A	Landing Length (in)	N/A	N/A	DWS Provided?	N/A
N/A	Landing Width (in)	N/A	N/A	DWS Contrast?	N/A
N/A	Landing Slope (%)	N/A	N/A	DWS Length (in)	N/A
N/A	Landing X Slope (%)	N/A	N/A	DWS Full Width?	N/A
N/A	Landing Curb? (Y/N)	N/A	N/A	DWS Offset (in)	N/A
N/A	Shared Landing?	N/A			
N/A	Gutter Ponding?	N/A	N/A	Gutter Slope (%)	N/A
N/A	Gutter Lip Ht (in)	N/A	N/A	Gutter X Slope (%)	N/A
N/A	Painted X Walk1?	No	N/A	Painted X Walk2?	N/A
	X Walk 1 Direction	To N		X Walk 2 Direction	N/A
N/A	X Walk 1 Width (in)	N/A	N/A	X Walk 2 Width (in)	N/A
	X Walk 1 Slope (%)	5.5		X Walk 2 Slope (%)	N/A
	X Walk 1 X Slope (%)	3.0		X Walk 2 X Slope (%)	N/A

N/A	Ramp inside XWalk1?	N/A	N/A	Ramp inside XWalk2?	N/A
	Road Slope (%)	N/A	N/A	Clear Space?	N/A
	Road X Slope (%)	N/A	N/A	Clear Space to XWalk (in)	N/A
N/A	Any Obstructions?	N/A	N/A	Storm Grate/Utility Hazard?	N/A
	Obstruction Type			Storm Grate/Utility Type	
		N/A			N/A
		Yes		Surface Condition? (G/P)	Good

**Remove & Replace Entire Ramp.**
