# Access Compliance Report

## Public Rights-of-Way

### (Curb Ramps)

Intersection ID: 6173	Main Street: OAKBLUFF_CR	Cross Street: PECANBLUFF_CT	Location: SW
ADA ID: B57511DF4618	Ramp Type: BlendTrans2	Initial Pass/Fail: Fail	Overall Compliance: No
Severity Score: 1.25			
Codes/Mitigation Info/Possible Solution		Field Measurements/Component Compliance

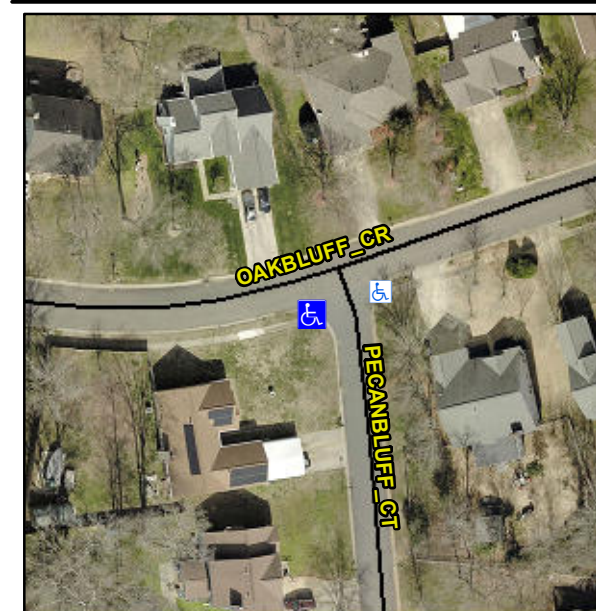
Compliance	Description	Data	Compliance	Description	Data
N/A	Ramp Length (in)	84.5	Yes	BlendTrans Slope (%)	0.8
Yes	Ramp Width (in)	48.0	No	BlendTrans XSlope (%)	4.7
N/A	Flare Type LT	N/A	N/A	Flare Type RT	N/A
N/A	Flare Slope LT (%)	N/A	N/A	Flare Slope RT (%)	N/A
N/A	Flare Traversable LT?	N/A	N/A	Flare Traversable RT?	N/A
N/A	Landing Length (in)	N/A	N/A	DWS Provided?	N/A
N/A	Landing Width (in)	N/A	N/A	DWS Contrast?	N/A
N/A	Landing Slope (%)	N/A	N/A	DWS Length (in)	N/A
N/A	Landing X Slope (%)	N/A	N/A	DWS Full Width?	N/A
N/A	Landing Curb? (Y/N)	N/A	N/A	DWS Offset (in)	N/A
N/A	Shared Landing?	N/A			
N/A	Gutter Ponding?	N/A	N/A	Gutter Slope (%)	N/A
N/A	Gutter Lip Ht (in)	N/A	N/A	Gutter X Slope (%)	N/A
N/A	Painted X Walk1?	No	N/A	Painted X Walk2?	N/A
	X Walk 1 Direction	To E		X Walk 2 Direction	N/A
	X Walk 1 Width (in)	N/A		X Walk 2 Width (in)	N/A
	X Walk 1 Slope (%)	5.1		X Walk 2 Slope (%)	N/A
	X Walk 1 X Slope (%)	2.6		X Walk 2 X Slope (%)	N/A

N/A	Ramp inside XWalk1?	N/A	N/A	Ramp inside XWalk2?	N/A
	Road Slope (%)	2.6		Clear Space?	N/A
	Road X Slope (%)	5.1	N/A	Clear Space to XWalk (in)	N/A
N/A	Any Obstructions?	N/A	N/A	Storm Grate/Utility Hazard?	N/A
	Obstruction Type			Storm Grate/Utility Type	
		N/A			N/A
			Yes	Surface Condition? (G/P)	Good
			No	Curb Slope (%)	8.0

Possible Solutions:

**Remove & Replace Curb Ramp With Two New Directional Ramps or Equivalent.**
