# Access Compliance Report

## Public Rights-of-Way

### (Curb Ramps)

Intersection ID: 44906	Main Street: OAK_DR	Cross Street: HAZELCROFT_LN	Location: NE
ADA ID: B5762EAE810A	Ramp Type: Perp	Initial Pass/Fail: Fail	Overall Compliance: No
Severity Score: 12.5			
Codes/Mitigation Info/Possible Solution		Field Measurements/Component Compliance

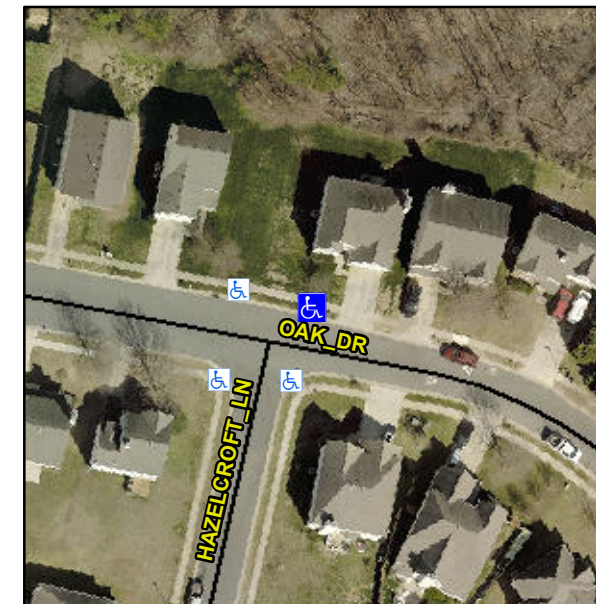
**Not Found, R304.2.2**

Compliance	Description	Data	Compliance	Description	Data
N/A	Ramp Length (in)	47.0	No	Ramp Slope (%)	11.6
Yes	Ramp Width (in)	48.0	Yes	Ramp XSlope (%)	0.3
N/A	Flare Type LT	N/A	N/A	Flare Type RT	N/A
N/A	Flare Slope LT (%)	N/A	N/A	Flare Slope RT (%)	N/A
N/A	Flare Traversable LT?	N/A	N/A	Flare Traversable RT?	N/A
N/A	Landing Length (in)	N/A	N/A	DWS Provided?	N/A
N/A	Landing Width (in)	N/A	N/A	DWS Contrast?	N/A
N/A	Landing Slope (%)	N/A	N/A	DWS Length (in)	N/A
N/A	Landing X Slope (%)	N/A	N/A	DWS Full Width?	N/A
N/A	Landing Curb? (Y/N)	N/A	N/A	DWS Offset (in)	N/A
N/A	Shared Landing?	N/A			
N/A	Gutter Ponding?	N/A	N/A	Gutter Slope (%)	N/A
N/A	Gutter Lip Ht (in)	1.0	N/A	Gutter X Slope (%)	N/A
N/A	Painted X Walk1?	No	N/A	Painted X Walk2?	N/A
	X Walk 1 Direction	To S		X Walk 2 Direction	N/A
N/A	X Walk 1 Width (in)	N/A	N/A	X Walk 2 Width (in)	N/A
	X Walk 1 Slope (%)	1.2		X Walk 2 Slope (%)	N/A
	X Walk 1 X Slope (%)	1.3		X Walk 2 X Slope (%)	N/A

**Remove & Replace Entire Ramp.**
