Access Compliance Report

Public Rights-of-Way

(Curb Ramps)

Intersection ID: 11842	Main Street: CAGLE_AV	Cross Street: N_SHARON_AMITY_RD	Location: NE
ADA ID: B57A05A0CB14	Ramp Type: Perp	Initial Pass/Fail: Fail	Overall Compliance: No
Severity Score: 13.75			
Codes/Mitigation Info/Possible Solution		Field Measurements/Component Compliance

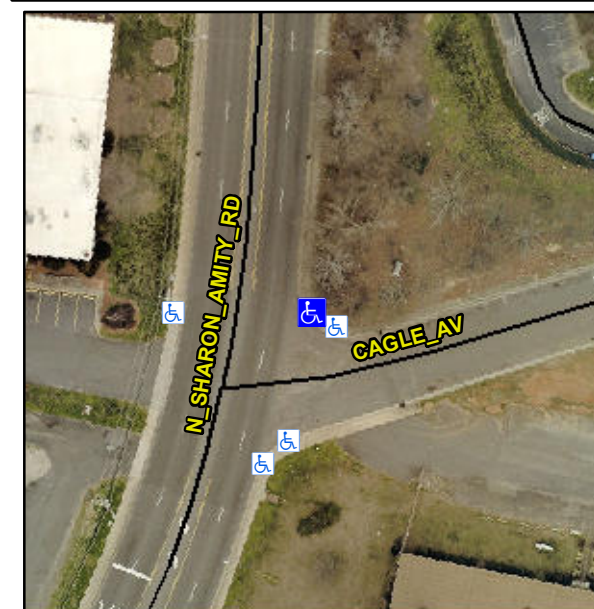
Not Found, R304.2.2, R304.5.3

Compliance	Description	Data	Compliance	Description	Data
N/A	Ramp Length (in)	59.5	No	Ramp Slope (%)	8.4
Yes	Ramp Width (in)	48.0	No	Ramp XSlope (%)	3.9
N/A	Flare Type LT	N/A	N/A	Flare Type RT	N/A
N/A	Flare Slope LT (%)	N/A	N/A	Flare Slope RT (%)	N/A
N/A	Flare Traversable LT?	N/A	N/A	Flare Traversable RT?	N/A
N/A	Landing Length (in)	N/A	N/A	DWS Provided?	N/A
N/A	Landing Width (in)	N/A	N/A	DWS Contrast?	N/A
N/A	Landing Slope (%)	N/A	N/A	DWS Length (in)	N/A
N/A	Landing X Slope (%)	N/A	N/A	DWS Full Width?	N/A
N/A	Landing Curb? (Y/N)	N/A	N/A	DWS Offset (in)	N/A
N/A	Shared Landing?	N/A			
N/A	Gutter Ponding?	N/A	N/A	Gutter Slope (%)	N/A
N/A	Gutter Lip Ht (in)	N/A	N/A	Gutter X Slope (%)	N/A
N/A	Painted X Walk1?	No	N/A	Painted X Walk2?	N/A
	X Walk 1 Direction	To W		X Walk 2 Direction	N/A
N/A	X Walk 1 Width (in)	N/A	N/A	X Walk 2 Width (in)	N/A
	X Walk 1 Slope (%)	6.8		X Walk 2 Slope (%)	N/A
	X Walk 1 X Slope (%)	0.5		X Walk 2 X Slope (%)	N/A

N/A	Ramp inside XWalk1?	N/A	N/A	Ramp inside XWalk2?	N/A
	Road Slope (%)	N/A	N/A	Clear Space?	N/A
	Road X Slope (%)	N/A	N/A	Clear Space to XWalk (in)	N/A
N/A	Any Obstructions?	N/A	N/A	Storm Grate/Utility Hazard?	N/A
	Obstruction Type			Storm Grate/Utility Type	
		N/A			N/A
		Yes		Surface Condition? (G/P)	Good

Possible Solutions:

Remove & Replace Entire Ramp.
