Access Compliance Report

Public Rights-of-Way

(Curb Ramps)

Intersection ID: 48587	Main Street: STONEY_CREEK_LN	Cross Street: UNIVERSITY_CITY_BV	Location: SW
ADA ID: B57F5FDC4380	Ramp Type: Perp	Initial Pass/Fail: Fail	Overall Compliance: No
Severity Score: 8.75			
Codes/Mitigation Info/Possible Solution		Field Measurements/Component Compliance

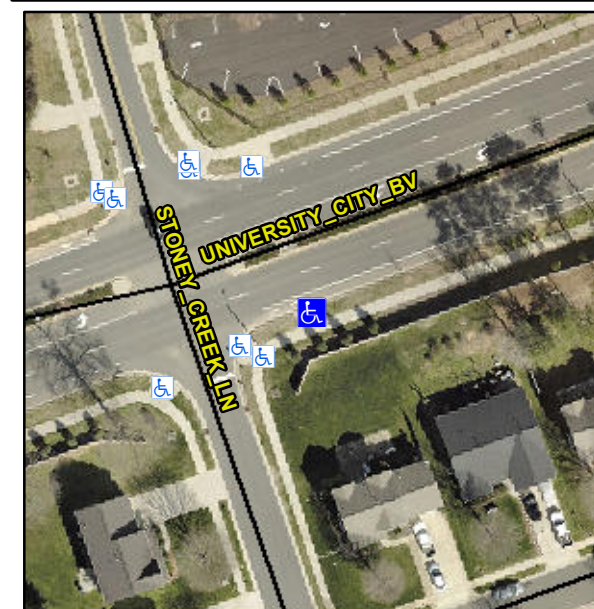
Compliance	Description	Data	Compliance	Description	Data
N/A	Ramp Length (in)	95.0	Yes	Ramp Slope (%)	7.4
No	Ramp Width (in)	47.0	Yes	Ramp XSlope (%)	0.1
N/A	Flare Type LT	N/A	N/A	Flare Type RT	N/A
N/A	Flare Slope LT (%)	N/A	N/A	Flare Slope RT (%)	N/A
N/A	Flare Traversable LT?	N/A	N/A	Flare Traversable RT?	N/A
N/A	Landing Length (in)	N/A	N/A	DWS Provided?	N/A
N/A	Landing Width (in)	N/A	N/A	DWS Contrast?	N/A
N/A	Landing Slope (%)	N/A	N/A	DWS Length (in)	N/A
N/A	Landing X Slope (%)	N/A	N/A	DWS Full Width?	N/A
N/A	Landing Curb? (Y/N)	N/A	N/A	DWS Offset (in)	N/A
N/A	Shared Landing?	N/A			
N/A	Gutter Ponding?	N/A	N/A	Gutter Slope (%)	N/A
N/A	Gutter Lip Ht (in)	N/A	N/A	Gutter X Slope (%)	N/A
N/A	Painted X Walk1?	No	N/A	Painted X Walk2?	N/A
	X Walk 1 Direction	To N		X Walk 2 Direction	N/A
N/A	X Walk 1 Width (in)	N/A	N/A	X Walk 2 Width (in)	N/A
	X Walk 1 Slope (%)	1.9		X Walk 2 Slope (%)	N/A
	X Walk 1 X Slope (%)	0.4		X Walk 2 X Slope (%)	N/A

N/A	Ramp inside XWalk1?	N/A	N/A	Ramp inside XWalk2?	N/A
	Road Slope (%)	N/A	N/A	Clear Space?	N/A
	Road X Slope (%)	N/A	N/A	Clear Space to XWalk (in)	N/A
N/A	Any Obstructions?	N/A	N/A	Storm Grate/Utility Hazard?	N/A
	Obstruction Type			Storm Grate/Utility Type	
		N/A			N/A
			Yes	Surface Condition? (G/P)	Good

Possible Solutions:

Remove & Replace Entire Ramp.

Not Found, R304.5.1
