Access Compliance Report

Public Rights-of-Way

(Curb Ramps)

Intersection ID: 11058	Main Street: N_I-77_EXIT_10B_RA	Cross Street: W_5TH_ST	Location:	N
ADA ID: B58353232811	Ramp Type: BlendTrans1	Initial Pass/Fail: Pass	Overall Compliance: No	Severity Score: 5
Codes/Mitigation Info/Possible Solution		Field Measurements/Component Compliance

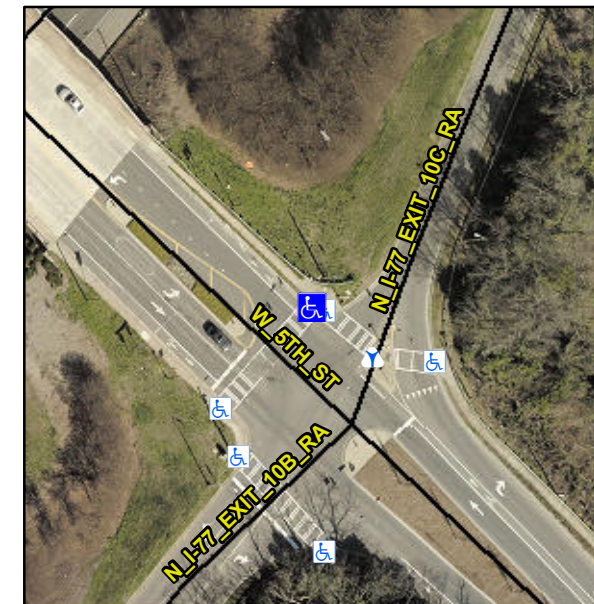
Not Found, R304.2.1, R304.2.3

Compliance	Description	Data	Compliance	Description	Data
N/A	Ramp Length (in)	27.0	Yes	BlendTrans Slope (%)	4.7
Yes	Ramp Width (in)	48.0	Yes	BlendTrans XSlope (%)	1.5
N/A	Flare Type LT	Sloped	No	Flare Type Curbed_WithWalkSurface	
N/A	Flare Slope LT (%)	3.1	N/A	Flare Slope RT (%)	N/A
N/A	Flare Traversable LT?	No	N/A	Flare Traversable RT?	No
Yes	Landing Length (in)	50.0	Yes	DWS Provided?	Yes
No	Landing Width (in)	24.0	Yes	DWS Contrast?	Yes
Yes	Landing Slope (%)	1.3	Yes	DWS Length (in)	24.0
Yes	Landing X Slope (%)	1.9	Yes	DWS Full Width?	Yes
N/A	Landing Curb? (Y/N)	No	Yes	DWS Offset (in)	0.0
N/A	Shared Landing?	Yes			
Yes	Gutter Ponding?	No	Yes	Gutter Slope (%)	3.6
Yes	Gutter Lip Ht (in)	0.0	Yes	Gutter X Slope (%)	0.3
N/A	Painted X Walk1?	Yes	N/A	Painted X Walk2?	N/A
	X Walk 1 Direction	To SW		X Walk 2 Direction	N/A
	X Walk 1 Width (in)	112.0		X Walk 2 Width (in)	N/A
	X Walk 1 Slope (%)	2.0		X Walk 2 Slope (%)	N/A

X Walk 1 X Slope (%)	1.5		X Walk 2 X Slope (%)	N/A
Yes	Ramp inside XWalk1?	Yes	N/A	Ramp inside XWalk2?	N/A
	Road Slope (%)	1.5		Clear Space?	Yes
	Road X Slope (%)	2.0	N/A	Clear Space to XWalk (in)	N/A
Yes	Any Obstructions?	No	Yes	Storm Grate/Utility Hazard?	No
	Obstruction Type			Storm Grate/Utility Type	
		N/A			N/A
			Yes	Surface Condition? (G/P)	Good
			No	Curb Slope (%)	14.1

Remove & Replace Curb Ramp With Two New Directional Ramps or Equivalent.
