# Access Compliance Report

## Public Rights-of-Way

| Intersection ID: 26408 | Main Street: BEVINGTON_PL | Cross Street: PEMBRY_LINKS_CR | Location: SW |
| ADA ID: B58432FA41AA | Ramp Type: PerpDiag | Initial Pass/Fail: Fail | Overall Compliance: No |

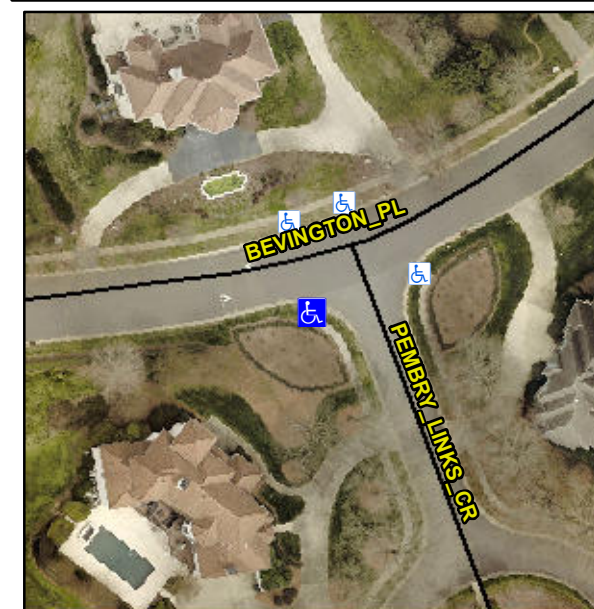
| Severity Score: 8.75 | | | |

| Compliance | Description | Data | Compliance | Description | Data |
|---|---|---|---|---|---|
| N/A | Ramp Length (in) | 116.0 | Yes | Ramp Slope (%) | 6.6 |
| No | Ramp Width (in) | 37.0 | Yes | Ramp XSlope (%) | 0.4 |

**Remove & Replace Curb Ramp With Two New Directional Ramps or Equivalent.**

**R304.5.1**

Total Cost: \$ 3200.00
