# Access Compliance Report

## Public Rights-of-Way

### (Curb Ramps)

Intersection ID: 18204	Main Street: IDLEWILD_RD	Cross Street: OAK_DR	Location:	N
ADA ID: B58CEF0C8B7E	Ramp Type: Directional1	Initial Pass/Fail: Fail	Overall Compliance: No	Severity Score: 12.5
Codes/Mitigation Info/Possible Solution		Field Measurements/Component Compliance

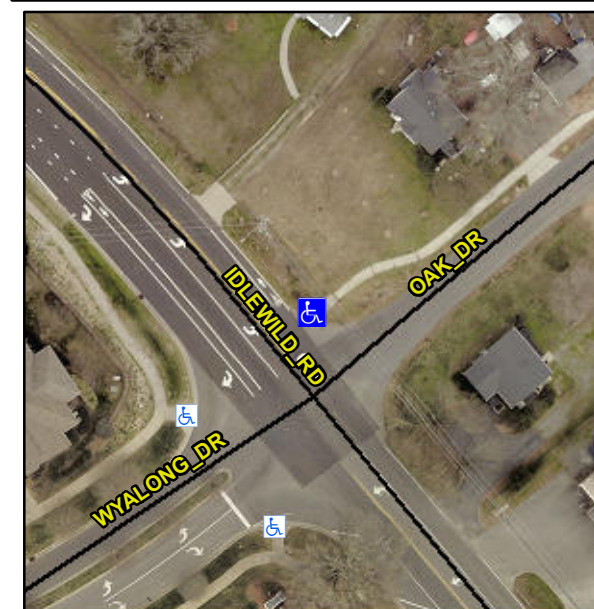
Compliance	Description	Data	Compliance	Description	Data
N/A	Ramp Length (in)	168.0	N/A	Grade Break?	N/A
Yes	Ramp Width (in)	72.0	N/A	Grade Break Slope (%)	0.0
No	Ramp Slope (%)	8.8	N/A	Grade Break XSlope (%)	0.0
Yes	Ramp XSlope (%)	1.5			
N/A	Flare Type LT	N/A	N/A	Flare Type RT	N/A
N/A	Flare Slope LT (%)	N/A	N/A	Flare Slope RT (%)	0.0
N/A	Flare Traversable LT?	N/A	N/A	Flare Traversable RT?	N/A
N/A	Landing Length (in)	0.0	N/A	DWS Provided?	N/A
N/A	Landing Width (in)	0.0	N/A	DWS Contrast?	N/A
N/A	Landing Slope (%)	0.0	N/A	DWS Length (in)	N/A
N/A	Landing X Slope (%)	0.0	N/A	DWS Full Width?	N/A
N/A	Landing Curb? (Y/N)	N/A	N/A	DWS Offset LT (in)	N/A
N/A	Shared Landing?	N/A	N/A	DWS Offset RT (in)	N/A
N/A	Gutter Ponding?	0.0	N/A	Gutter Slope (%)	N/A
N/A	Gutter Lip Ht (in)	0.0	N/A	Gutter X Slope (%)	N/A
N/A	Painted X Walk1?	No		Road Slope (%)	1.9
	X Walk 1 Direction	To SW		Road X Slope (%)	1.8
	X Walk 1 Width (in)	N/A		Clear Space?	N/A

X Walk 1 Slope (%)	1.9	N/A	Clear Space to XWalk (in)	N/A
	X Walk 1 X Slope (%)	1.8	N/A	Storm Grate/Utility Hazard?	N/A
N/A	Ramp inside XWalk1?	N/A		Storm Grate/Utility Type	
N/A	Any Obstructions?	N/A			N/A
	Obstruction Type		Yes	Surface Condition? (G/P)	Good
			N/A	Curb Slope (%)	0.2

Possible Solutions:

**Remove & Replace Entire Ramp.**

PROW/ADA:

**R304.2.2**
