Access Compliance Report

Public Rights-of-Way

(Curb Ramps)

Intersection ID: 14794	Main Street: BUCHANAN_ST	Cross Street: DILWORTH_RD_EAST	Location: NE
ADA ID: B5980B68E7FD	Ramp Type: Perp	Initial Pass/Fail: Fail	Overall Compliance: No
Severity Score: 12.5			
Codes/Mitigation Info/Possible Solution		Field Measurements/Component Compliance

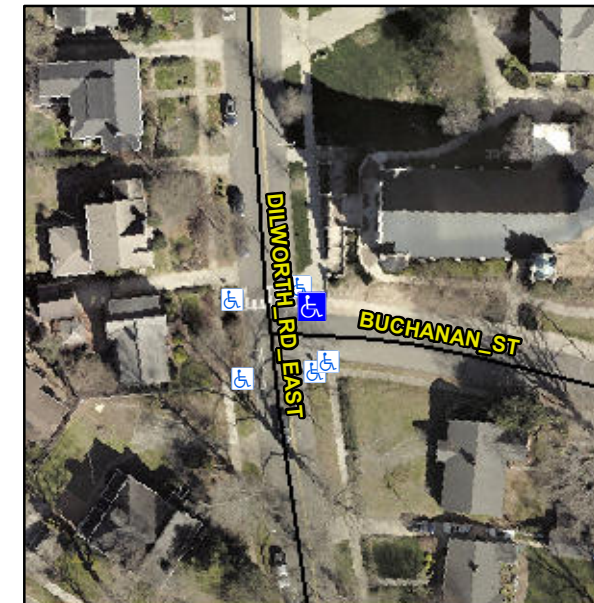
Compliance	Description	Data	Compliance	Description	Data
N/A	Ramp Length (in)	51.0	Yes	Ramp Slope (%)	5.1
Yes	Ramp Width (in)	84.0	No	Ramp XSlope (%)	5.3
N/A	Flare Type LT	N/A	N/A	Flare Type RT	N/A
N/A	Flare Slope LT (%)	N/A	N/A	Flare Slope RT (%)	N/A
N/A	Flare Traversable LT?	N/A	N/A	Flare Traversable RT?	N/A
N/A	Landing Length (in)	N/A	N/A	DWS Provided?	N/A
N/A	Landing Width (in)	N/A	N/A	DWS Contrast?	N/A
N/A	Landing Slope (%)	N/A	N/A	DWS Length (in)	N/A
N/A	Landing X Slope (%)	N/A	N/A	DWS Full Width?	N/A
N/A	Landing Curb? (Y/N)	N/A	N/A	DWS Offset (in)	N/A
N/A	Shared Landing?	N/A			
N/A	Gutter Ponding?	N/A	N/A	Gutter Slope (%)	N/A
N/A	Gutter Lip Ht (in)	N/A	N/A	Gutter X Slope (%)	N/A
N/A	Painted X Walk1?	No	N/A	Painted X Walk2?	N/A
	X Walk 1 Direction	To S		X Walk 2 Direction	N/A
N/A	X Walk 1 Width (in)	N/A	N/A	X Walk 2 Width (in)	N/A
	X Walk 1 Slope (%)	6.2		X Walk 2 Slope (%)	N/A
	X Walk 1 X Slope (%)	3.7		X Walk 2 X Slope (%)	N/A

N/A	Ramp inside XWalk1?	N/A	N/A	Ramp inside XWalk2?	N/A
	Road Slope (%)	N/A	N/A	Clear Space?	N/A
	Road X Slope (%)	N/A	N/A	Clear Space to XWalk (in)	N/A
N/A	Any Obstructions?	N/A	N/A	Storm Grate/Utility Hazard?	N/A
	Obstruction Type			Storm Grate/Utility Type	
		N/A			N/A
		Yes		Surface Condition? (G/P)	Good

Possible Solutions:

Remove & Replace Entire Ramp.
