Access Compliance Report Public Rights-of-Way (Curb Ramps)

Intersection ID: 14317 Main Street: RAMPART ST **Cross Street: S TRYON ST** Location: NE Initial Pass/Fail: Fail **Overall Compliance: No** ADA ID: B59833968168 Ramp Type: PerpDiag Severity Score: 21.25

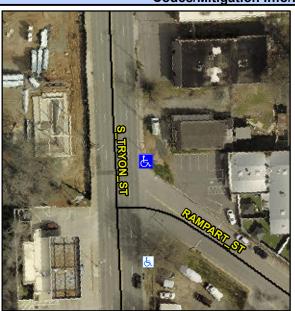
S TRYON ST Street 1 Name Stop Condition-Street 2 RAMPART ST Street 2 Name Stop Condition-Street 1 StopSign Possible Solutions: Remove & Replace Curb Ramp With Two New Directional Ramps or Equivalent. Surveyor Notes: N/A PROW/ADA: Not Found, R304.5.1, R304.2.2

Total Cost: 3200.00 Compliance Description Data Compliance Description Data No N/A Ramp Length (in) 48.0 Ramp Slope (%) 11.7 Yes Ramp XSlope (%) No Ramp Width (in) 37.0 2.0 N/A N/A Flare Type LT N/A Flare Type RT N/A N/A N/A N/A Flare Slope RT (%) N/A Flare Slope LT (%) N/A Flare Traversable LT? N/A N/A Flare Traversable RT? N/A N/A N/A N/A **DWS Provided?** N/A Landing Length (in) N/A Landing Width (in) N/A N/A **DWS Contrast?** N/A N/A N/A N/A Landing Slope (%) DWS Length (in) N/A N/A Landing X Slope (%) N/A N/A DWS Full Width? N/A N/A Landing Curb? (Y/N) N/A N/A DWS Offset (in) N/A N/A N/A Shared Landing? N/A **Gutter Ponding?** N/A N/A Gutter Slope (%) N/A N/A Gutter Lip Ht (in) N/A N/A Gutter X Slope (%) N/A N/A Painted X Walk1? No N/A Painted X Walk2? No X Walk 1 Direction To W X Walk 2 Direction To S N/A N/A N/A X Walk 1 Width (in) X Walk 2 Width (in) N/A X Walk 1 Slope (%) 1.6 X Walk 2 Slope (%) 0.0 X Walk 1 X Slope (%) 1.6 X Walk 2 X Slope (%) 1.1 N/A N/A N/A Ramp inside XWalk2? N/A Ramp inside XWalk1? Road Slope (%) 3.1 N/A Clear Space? N/A N/A Road X Slope (%) 4.0 Clear Space to XWalk (in) N/A N/A N/A N/A Any Obstructions? Storm Grate/Utility Hazard? N/A **Obstruction Type** Storm Grate/Utility Type N/A N/A Yes Surface Condition? (G/P) Good
