Access Compliance Report

Public Rights-of-Way

(Curb Ramps)

Intersection ID: 22211	Main Street: SHARON_VIEW_RD	Cross Street: VAUXHALL_CT	Location: E
ADA ID: B59EA80E0136	Ramp Type: PerpDiag	Initial Pass/Fail: Fail	Overall Compliance: No
Severity Score: 10			
Codes/Mitigation Info/Possible Solution		Field Measurements/Component Compliance

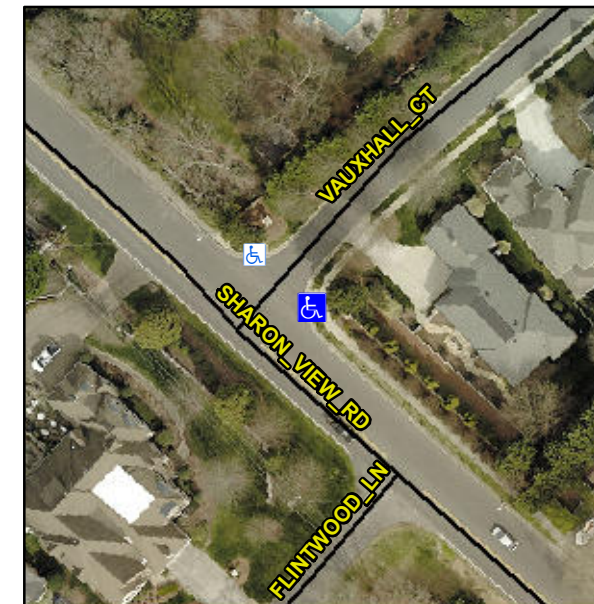
Compliance	Description	Data	Compliance	Description	Data
N/A	Ramp Length (in)	47.0	Yes	Ramp Slope (%)	6.8
No	Ramp Width (in)	42.0	No	Ramp XSlope (%)	2.2
N/A	Flare Type LT	N/A	N/A	Flare Type RT	N/A
N/A	Flare Slope LT (%)	N/A	N/A	Flare Slope RT (%)	N/A
N/A	Flare Traversable LT?	N/A	N/A	Flare Traversable RT?	N/A
N/A	Landing Length (in)	N/A	N/A	DWS Provided?	N/A
N/A	Landing Width (in)	N/A	N/A	DWS Contrast?	N/A
N/A	Landing Slope (%)	N/A	N/A	DWS Length (in)	N/A
N/A	Landing X Slope (%)	N/A	N/A	DWS Full Width?	N/A
N/A	Landing Curb? (Y/N)	N/A	N/A	DWS Offset (in)	N/A
N/A	Shared Landing?	N/A			
N/A	Gutter Ponding?	N/A	N/A	Gutter Slope (%)	N/A
N/A	Gutter Lip Ht (in)	N/A	N/A	Gutter X Slope (%)	N/A
N/A	Painted X Walk1?	No	N/A	Painted X Walk2?	No
	X Walk 1 Direction	To NW		X Walk 2 Direction	To SW
N/A	X Walk 1 Width (in)	N/A	N/A	X Walk 2 Width (in)	N/A
	X Walk 1 Slope (%)	3.6		X Walk 2 Slope (%)	0.4
	X Walk 1 X Slope (%)	1.7		X Walk 2 X Slope (%)	1.3

N/A	Ramp inside XWalk1?	N/A	N/A	Ramp inside XWalk2?	N/A
	Road Slope (%)	0.5	N/A	Clear Space?	N/A
	Road X Slope (%)	5.1	N/A	Clear Space to XWalk (in)	N/A
N/A	Any Obstructions?	N/A	N/A	Storm Grate/Utility Hazard?	N/A
	Obstruction Type			Storm Grate/Utility Type	
		N/A			N/A
			Yes	Surface Condition? (G/P)	Good

Possible Solutions:

Remove & Replace Curb Ramp With Two New Directional Ramps or Equivalent.

R304.5.1, R304.5.3
