Access Compliance Report

Public Rights-of-Way (Curb Ramps)

Intersection ID: 13450	Main Street: S_MCDOWELL_ST	Cross Street: E_MARTIN_LUTHER_KING_JR_BV	Location: E
ADA ID: B5A4BD22AEE6	Ramp Type: BlendTrans1	Initial Pass/Fail: Pass	Overall Compliance: No
		Severity Score: 0

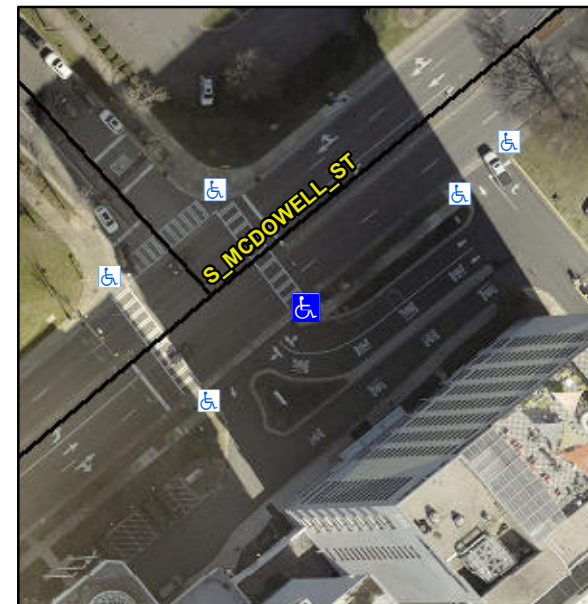
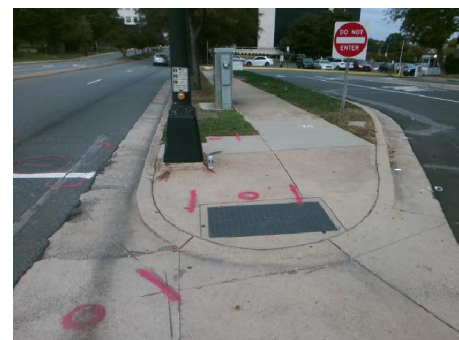
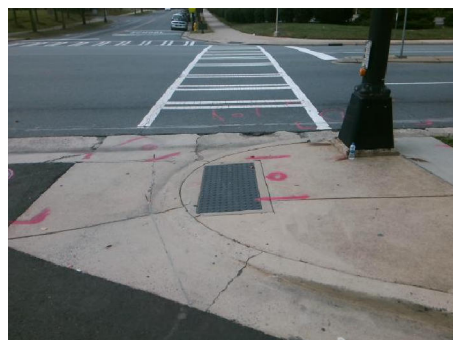
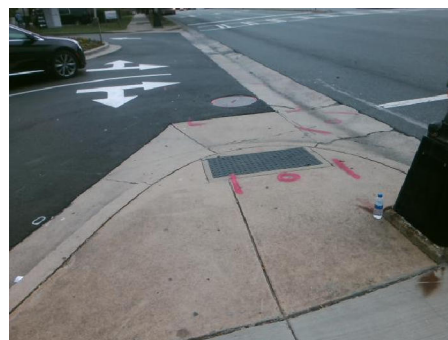
Not Found, R305.2

Compliance	Description	Data	Compliance	Description	Data
N/A	Ramp Length (in)	71.0	Yes	BlendTrans Slope (%)	4.5
Yes	Ramp Width (in)	48.0	Yes	BlendTrans XSlope (%)	1.5
N/A	Flare Type LT	Sloped	N/A	Flare Type RT	Sloped
N/A	Flare Slope LT (%)	3.9	N/A	Flare Slope RT (%)	4.5
N/A	Flare Traversable LT?	No	N/A	Flare Traversable RT?	No
Yes	Landing Length (in)	48.0	Yes	DWS Provided?	Yes
Yes	Landing Width (in)	48.0	Yes	DWS Contrast?	Yes
Yes	Landing Slope (%)	0.6	Yes	DWS Length (in)	24.0
Yes	Landing X Slope (%)	0.6	Yes	DWS Full Width?	Yes
N/A	Landing Curb? (Y/N)	No	No	DWS Offset (in)	8.5
N/A	Shared Landing?	No			
Yes	Gutter Ponding?	No	Yes	Gutter Slope (%)	3.1
Yes	Gutter Lip Ht (in)	0.0	Yes	Gutter X Slope (%)	2.1
N/A	Painted X Walk1?	Yes	N/A	Painted X Walk2?	No
	X Walk 1 Direction	To N		X Walk 2 Direction	To S
	X Walk 1 Width (in)	110.0		X Walk 2 Width (in)	N/A
	X Walk 1 Slope (%)	1.7		X Walk 2 Slope (%)	3.9
	X Walk 1 X Slope (%)	1.1		X Walk 2 X Slope (%)	0.8

Yes	Ramp inside XWalk1?	Yes	N/A	Ramp inside XWalk2?	N/A
	Road Slope (%)	2.5		Clear Space?	Yes
	Road X Slope (%)	2.3	N/A	Clear Space to XWalk (in)	N/A
Yes	Any Obstructions?	No	Yes	Storm Grate/Utility Hazard?	No
	Obstruction Type			Storm Grate/Utility Type	
		N/A			N/A
			Yes	Surface Condition? (G/P)	Good
			No	Curb Slope (%)	7.7

Remove & Replace Curb Ramp With Two New Directional Ramps or Equivalent.

Total Cost: \$ 3200.00
