Access Compliance Report

Public Rights-of-Way

(Curb Ramps)

Intersection ID: 15469	Main Street: LATROBE_DR	Cross Street: PRO_AM_DR	Location: NW
ADA ID: B5A7A8583A4D	Ramp Type: PerpDiag	Initial Pass/Fail: Pass	Overall Compliance: No
Codes/Mitigation Info/Possible Solution		Field Measurements/Component Compliance

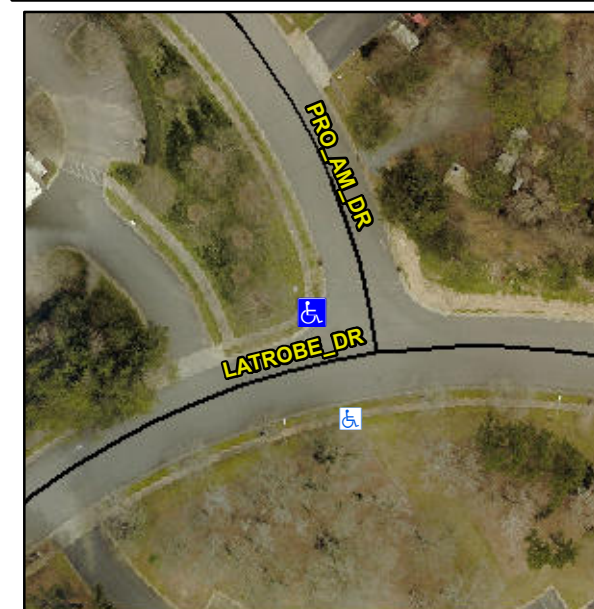
Not Found, R304.5.3, R304.2.1, R304.2.2-Perp, R304.3.2-Para, R304.2.3, R305.1.4, R305.2

Compliance	Description	Data	Compliance	Description	Data
N/A	Ramp Length (in)	47.0	Yes	Ramp Slope (%)	6.5
Yes	Ramp Width (in)	51.5	No	Ramp XSlope (%)	4.3
N/A	Flare Type LT	Sloped	N/A	Flare Type RT	N/A
N/A	Flare Slope LT (%)	2.8	No	Flare Slope RT (%)	12.1
N/A	Flare Traversable LT?	Yes	N/A	Flare Traversable RT?	Yes
No	Landing Length (in)	47.5	Yes	DWS Provided?	Yes
No	Landing Width (in)	45.0	Yes	DWS Contrast?	Yes
No	Landing Slope (%)	2.4	Yes	DWS Length (in)	25.5
No	Landing X Slope (%)	3.0	No	DWS Full Width?	No
N/A	Landing Curb? (Y/N)	No	No	DWS Offset (in)	3.0
N/A	Shared Landing?	No			
Yes	Gutter Ponding?	No	Yes	Gutter Slope (%)	2.5
Yes	Gutter Lip Ht (in)	0.0	Yes	Gutter X Slope (%)	1.2
N/A	Painted X Walk1?	No	N/A	Painted X Walk2?	No
	X Walk 1 Direction	To S		X Walk 2 Direction	To E
N/A	X Walk 1 Width (in)	N/A	N/A	X Walk 2 Width (in)	N/A
	X Walk 1 Slope (%)	2.1		X Walk 2 Slope (%)	1.3
	X Walk 1 X Slope (%)	0.2		X Walk 2 X Slope (%)	2.8

N/A	Ramp inside XWalk1?	N/A	N/A	Ramp inside XWalk2?	N/A
	Road Slope (%)	2.5	N/A	Clear Space?	Yes
	Road X Slope (%)	0.6	N/A	Clear Space to XWalk (in)	N/A
Yes	Any Obstructions?	No	Yes	Storm Grate/Utility Hazard?	No
	Obstruction Type			Storm Grate/Utility Type	
		N/A			N/A
			Yes	Surface Condition? (G/P)	Good

Remove & Replace Curb Ramp With Two New Directional Ramps or Equivalent.
