Access Compliance Report

Public Rights-of-Way

(Curb Ramps)

Intersection ID: 20612	Main Street: ARTWOOD_LN	Cross Street: WOODKNOLL_DR	Location: N
ADA ID: B5AA9CFD1D93	Ramp Type: Perp	Initial Pass/Fail: Fail	Overall Compliance: No
		Severity Score: 47.5

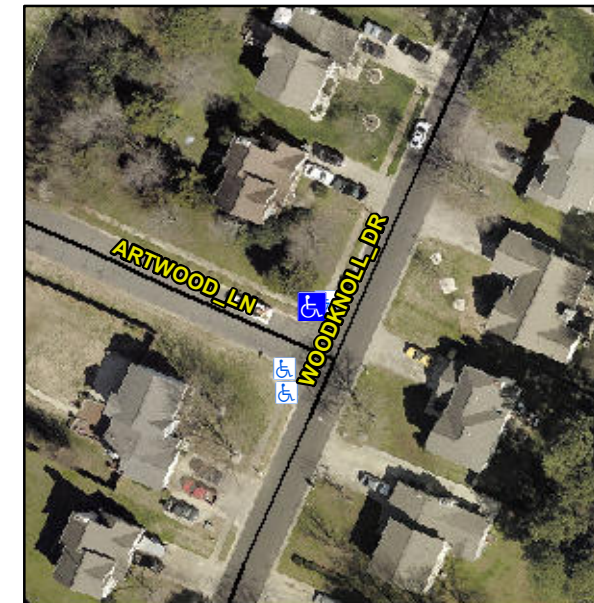
Not Found, R304.5.1, R304.2.2

Compliance	Description	Data	Compliance	Description	Data
N/A	Ramp Length (in)	93.0	No	Ramp Slope (%)	9.2
No	Ramp Width (in)	26.0	Yes	Ramp XSlope (%)	1.2
N/A	Flare Type LT	N/A	N/A	Flare Type RT	N/A
N/A	Flare Slope LT (%)	N/A	N/A	Flare Slope RT (%)	N/A
N/A	Flare Traversable LT?	N/A	N/A	Flare Traversable RT?	N/A
N/A	Landing Length (in)	N/A	N/A	DWS Provided?	N/A
N/A	Landing Width (in)	N/A	N/A	DWS Contrast?	N/A
N/A	Landing Slope (%)	N/A	N/A	DWS Length (in)	N/A
N/A	Landing X Slope (%)	N/A	N/A	DWS Full Width?	N/A
N/A	Landing Curb? (Y/N)	N/A	N/A	DWS Offset (in)	N/A
N/A	Shared Landing?	N/A			
N/A	Gutter Ponding?	N/A	N/A	Gutter Slope (%)	N/A
N/A	Gutter Lip Ht (in)	N/A	N/A	Gutter X Slope (%)	N/A
N/A	Painted X Walk1?	No	N/A	Painted X Walk2?	N/A
	X Walk 1 Direction	To SW		X Walk 2 Direction	N/A
N/A	X Walk 1 Width (in)	N/A	N/A	X Walk 2 Width (in)	N/A
	X Walk 1 Slope (%)	1.5		X Walk 2 Slope (%)	N/A
	X Walk 1 X Slope (%)	0.5		X Walk 2 X Slope (%)	N/A

N/A	Ramp inside XWalk1?	N/A	N/A	Ramp inside XWalk2?	N/A
	Road Slope (%)	N/A	N/A	Clear Space?	N/A
	Road X Slope (%)	N/A	N/A	Clear Space to XWalk (in)	N/A
N/A	Any Obstructions?	N/A	N/A	Storm Grate/Utility Hazard?	N/A
	Obstruction Type			Storm Grate/Utility Type	
		N/A			N/A
			Yes	Surface Condition? (G/P)	Good

Remove & Replace Entire Ramp.
