# Access Compliance Report

## Public Rights-of-Way

### (Curb Ramps)

Intersection ID: 11273	Main Street: E_21ST_ST	Cross Street: N_DAVIDSON_ST	Location: N
ADA ID: B5B07DE43DC2	Ramp Type: BlendTrans1	Initial Pass/Fail: Fail	Overall Compliance: No
Severity Score: 21.25			
Codes/Mitigation Info/Possible Solution		Field Measurements/Component Compliance

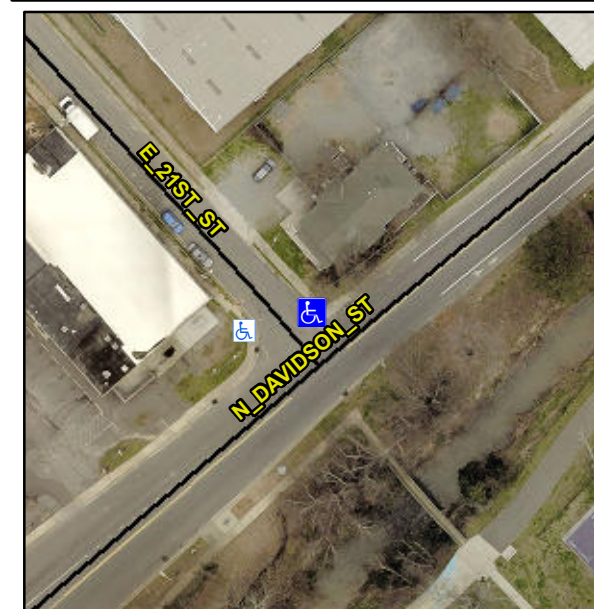
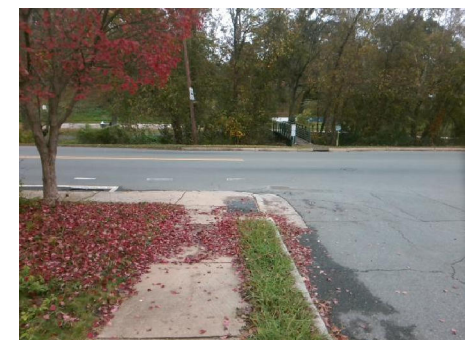
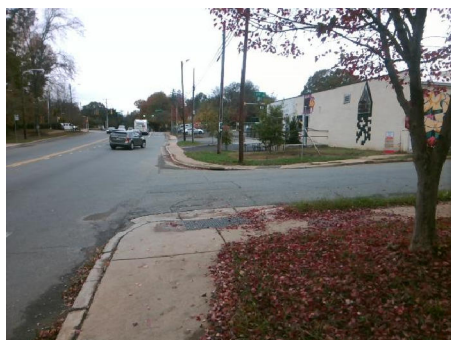
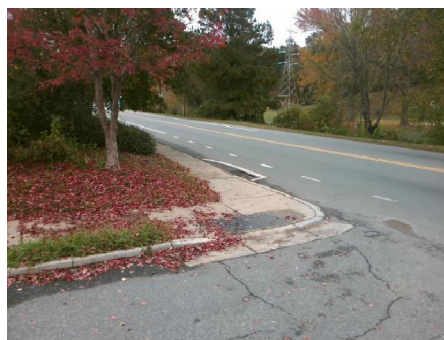
**Not Found, R304.5.1, R304.5.3**

Compliance	Description	Data	Compliance	Description	Data
N/A	Ramp Length (in)	25.5	Yes	BlendTrans Slope (%)	4.7
No	Ramp Width (in)	46.5	No	BlendTrans XSlope (%)	5.9
N/A	Flare Type LT	N/A	N/A	Flare Type RT	N/A
N/A	Flare Slope LT (%)	N/A	N/A	Flare Slope RT (%)	N/A
N/A	Flare Traversable LT?	N/A	N/A	Flare Traversable RT?	N/A
N/A	Landing Length (in)	N/A	N/A	DWS Provided?	N/A
N/A	Landing Width (in)	N/A	N/A	DWS Contrast?	N/A
N/A	Landing Slope (%)	N/A	N/A	DWS Length (in)	N/A
N/A	Landing X Slope (%)	N/A	N/A	DWS Full Width?	N/A
N/A	Landing Curb? (Y/N)	N/A	N/A	DWS Offset (in)	N/A
N/A	Shared Landing?	N/A			
N/A	Gutter Ponding?	N/A	N/A	Gutter Slope (%)	N/A
N/A	Gutter Lip Ht (in)	N/A	N/A	Gutter X Slope (%)	N/A
N/A	Painted X Walk1?	No	N/A	Painted X Walk2?	N/A
	X Walk 1 Direction	To W		X Walk 2 Direction	N/A
	X Walk 1 Width (in)	N/A		X Walk 2 Width (in)	N/A
	X Walk 1 Slope (%)	4.5		X Walk 2 Slope (%)	N/A
	X Walk 1 X Slope (%)	2.7		X Walk 2 X Slope (%)	N/A

N/A	Ramp inside XWalk1?	N/A	N/A	Ramp inside XWalk2?	N/A
	Road Slope (%)	2.7		Clear Space?	N/A
	Road X Slope (%)	4.5	N/A	Clear Space to XWalk (in)	N/A
N/A	Any Obstructions?	N/A	N/A	Storm Grate/Utility Hazard?	N/A
	Obstruction Type			Storm Grate/Utility Type	
		N/A			N/A
			Yes	Surface Condition? (G/P)	Good
			No	Curb Slope (%)	9.2

**Remove & Replace Curb Ramp With Two New Directional Ramps or Equivalent.**
