Access Compliance Report

Public Rights-of-Way

(Curb Ramps)

Intersection ID: 7563	Main Street: WALDON_RD	Cross Street: SHARPES_CR	Location: SE
ADA ID: B5B580D03EA7	Ramp Type: Perp	Initial Pass/Fail: Fail	Overall Compliance: No
Severity Score: 8.75			
Codes/Mitigation Info/Possible Solution		Field Measurements/Component Compliance

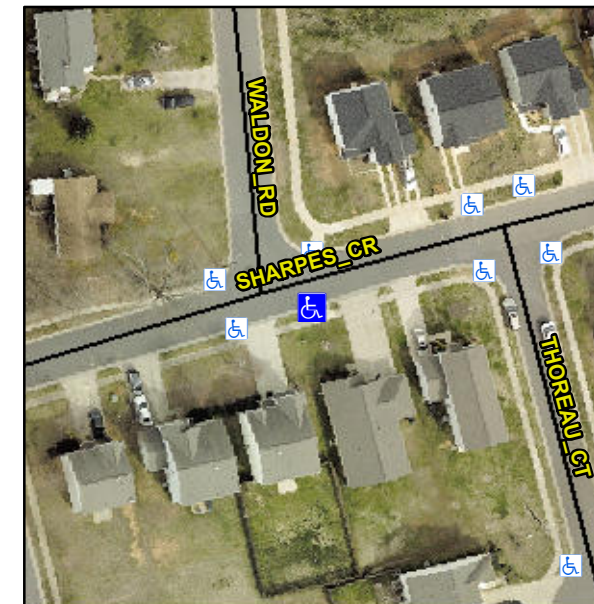
Not Found, R304.5.1

Compliance	Description	Data	Compliance	Description	Data
N/A	Ramp Length (in)	48.5	Yes	Ramp Slope (%)	5.6
No	Ramp Width (in)	47.5	Yes	Ramp XSlope (%)	1.5
N/A	Flare Type LT	N/A	N/A	Flare Type RT	N/A
N/A	Flare Slope LT (%)	N/A	N/A	Flare Slope RT (%)	N/A
N/A	Flare Traversable LT?	N/A	N/A	Flare Traversable RT?	N/A
N/A	Landing Length (in)	N/A	N/A	DWS Provided?	N/A
N/A	Landing Width (in)	N/A	N/A	DWS Contrast?	N/A
N/A	Landing Slope (%)	N/A	N/A	DWS Length (in)	N/A
N/A	Landing X Slope (%)	N/A	N/A	DWS Full Width?	N/A
N/A	Landing Curb? (Y/N)	N/A	N/A	DWS Offset (in)	N/A
N/A	Shared Landing?	N/A			
N/A	Gutter Ponding?	N/A	N/A	Gutter Slope (%)	N/A
N/A	Gutter Lip Ht (in)	N/A	N/A	Gutter X Slope (%)	N/A
N/A	Painted X Walk1?	No	N/A	Painted X Walk2?	N/A
	X Walk 1 Direction	To N		X Walk 2 Direction	N/A
N/A	X Walk 1 Width (in)	N/A	N/A	X Walk 2 Width (in)	N/A
	X Walk 1 Slope (%)	8.1		X Walk 2 Slope (%)	N/A
	X Walk 1 X Slope (%)	1.9		X Walk 2 X Slope (%)	N/A

N/A	Ramp inside XWalk1?	N/A	N/A	Ramp inside XWalk2?	N/A
	Road Slope (%)	N/A	N/A	Clear Space?	N/A
	Road X Slope (%)	N/A	N/A	Clear Space to XWalk (in)	N/A
N/A	Any Obstructions?	N/A	N/A	Storm Grate/Utility Hazard?	N/A
	Obstruction Type			Storm Grate/Utility Type	
		N/A			N/A
			Yes	Surface Condition? (G/P)	Good

Possible Solutions:

Remove & Replace Entire Ramp.
