Access Compliance Report

Public Rights-of-Way

(Curb Ramps)

Intersection ID: 10485	Main Street: ANDERSON_ST	Cross Street: THE_PLAZA	Location: E
ADA ID: B5B87CCB8710	Ramp Type: Perp	Initial Pass/Fail: Fail	Overall Compliance: No
			Severity Score: 33.75

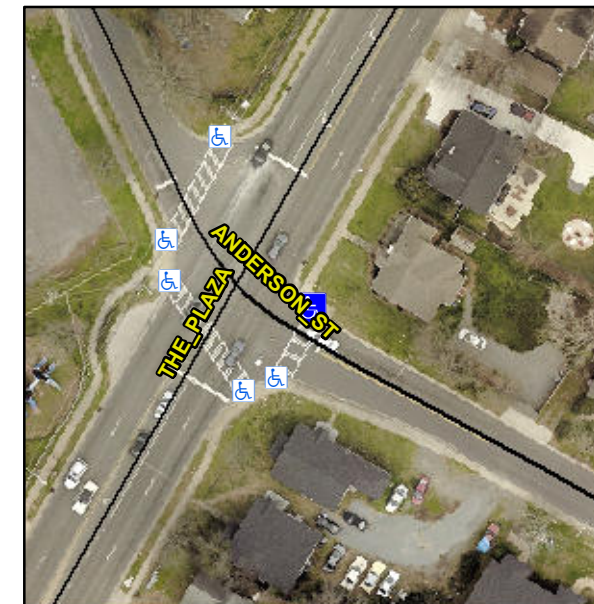
Not Found, R304.5.1, R304.5.3

Compliance	Description	Data	Compliance	Description	Data
N/A	Ramp Length (in)	68.5	Yes	Ramp Slope (%)	8.1
No	Ramp Width (in)	47.0	No	Ramp XSlope (%)	7.3
N/A	Flare Type LT	N/A	N/A	Flare Type RT	N/A
N/A	Flare Slope LT (%)	N/A	N/A	Flare Slope RT (%)	N/A
N/A	Flare Traversable LT?	N/A	N/A	Flare Traversable RT?	N/A
N/A	Landing Length (in)	N/A	N/A	DWS Provided?	N/A
N/A	Landing Width (in)	N/A	N/A	DWS Contrast?	N/A
N/A	Landing Slope (%)	N/A	N/A	DWS Length (in)	N/A
N/A	Landing X Slope (%)	N/A	N/A	DWS Full Width?	N/A
N/A	Landing Curb? (Y/N)	N/A	N/A	DWS Offset (in)	N/A
N/A	Shared Landing?	N/A			
N/A	Gutter Ponding?	N/A	N/A	Gutter Slope (%)	N/A
N/A	Gutter Lip Ht (in)	N/A	N/A	Gutter X Slope (%)	N/A
N/A	Painted X Walk1?	Yes	N/A	Painted X Walk2?	N/A
	X Walk 1 Direction	To SW		X Walk 2 Direction	N/A
N/A	X Walk 1 Width (in)	110.5	N/A	X Walk 2 Width (in)	N/A
	X Walk 1 Slope (%)	2.6		X Walk 2 Slope (%)	N/A
	X Walk 1 X Slope (%)	6.5		X Walk 2 X Slope (%)	N/A

N/A	Ramp inside XWalk1?	Yes	N/A	Ramp inside XWalk2?	N/A
	Road Slope (%)	N/A	N/A	Clear Space?	N/A
	Road X Slope (%)	N/A	N/A	Clear Space to XWalk (in)	N/A
N/A	Any Obstructions?	N/A	N/A	Storm Grate/Utility Hazard?	N/A
	Obstruction Type			Storm Grate/Utility Type	
		N/A			N/A
			Yes	Surface Condition? (G/P)	Good

Remove & Replace Entire Ramp.
