Access Compliance Report

Public Rights-of-Way

(Curb Ramps)

Intersection ID: 4705	Main Street: HARRIS_HOUSTON_RD	Cross Street: KEMPSFORD_DR	Location:	N
ADA ID: B5C2C7C21590	Ramp Type: Perp	Initial Pass/Fail: Fail	Overall Compliance: No	Severity Score: 13.75

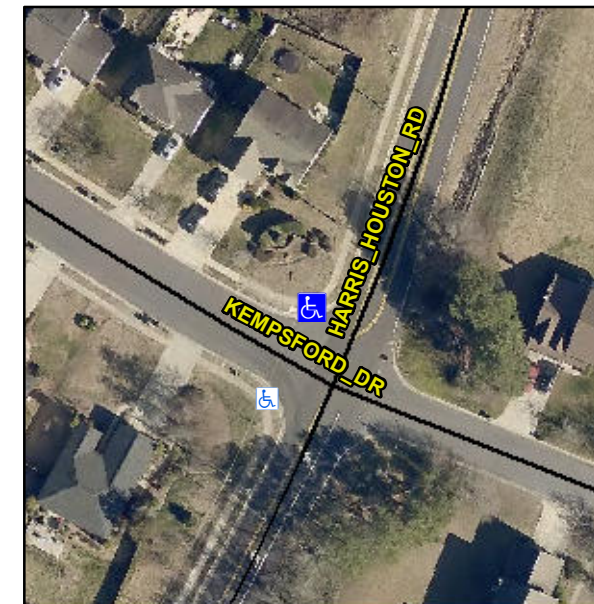
R304.2.2, R304.5.3

Compliance	Description	Data	Compliance	Description	Data
N/A	Ramp Length (in)	47.0	No	Ramp Slope (%)	9.0
Yes	Ramp Width (in)	50.0	No	Ramp XSlope (%)	4.8
N/A	Flare Type LT	N/A	N/A	Flare Type RT	N/A
N/A	Flare Slope LT (%)	N/A	N/A	Flare Slope RT (%)	N/A
N/A	Flare Traversable LT?	N/A	N/A	Flare Traversable RT?	N/A
N/A	Landing Length (in)	N/A	N/A	DWS Provided?	N/A
N/A	Landing Width (in)	N/A	N/A	DWS Contrast?	N/A
N/A	Landing Slope (%)	N/A	N/A	DWS Length (in)	N/A
N/A	Landing X Slope (%)	N/A	N/A	DWS Full Width?	N/A
N/A	Landing Curb? (Y/N)	N/A	N/A	DWS Offset (in)	N/A
N/A	Shared Landing?	N/A			
N/A	Gutter Ponding?	N/A	N/A	Gutter Slope (%)	N/A
N/A	Gutter Lip Ht (in)	N/A	N/A	Gutter X Slope (%)	N/A
N/A	Painted X Walk1?	No	N/A	Painted X Walk2?	N/A
	X Walk 1 Direction	To SW		X Walk 2 Direction	N/A
N/A	X Walk 1 Width (in)	N/A	N/A	X Walk 2 Width (in)	N/A
	X Walk 1 Slope (%)	6.7		X Walk 2 Slope (%)	N/A
	X Walk 1 X Slope (%)	3.9		X Walk 2 X Slope (%)	N/A

N/A	Ramp inside XWalk1?	N/A	N/A	Ramp inside XWalk2?	N/A
	Road Slope (%)	N/A	N/A	Clear Space?	N/A
	Road X Slope (%)	N/A	N/A	Clear Space to XWalk (in)	N/A
N/A	Any Obstructions?	N/A	N/A	Storm Grate/Utility Hazard?	N/A
	Obstruction Type			Storm Grate/Utility Type	
		N/A			N/A
			Yes	Surface Condition? (G/P)	Good

Remove & Replace Entire Ramp.

Total Cost: \$ 1850.00
