Access Compliance Report

Public Rights-of-Way

(Curb Ramps)

Intersection ID: 10038172	Main Street: SIR_CHARLES_PL	Cross Street: N/A	Location: SW
ADA ID: B5C45A85C5DB	Ramp Type: BlendTrans2	Initial Pass/Fail: Fail	Overall Compliance: No
Severity Score: 8.75			
Codes/Mitigation Info/Possible Solution		Field Measurements/Component Compliance

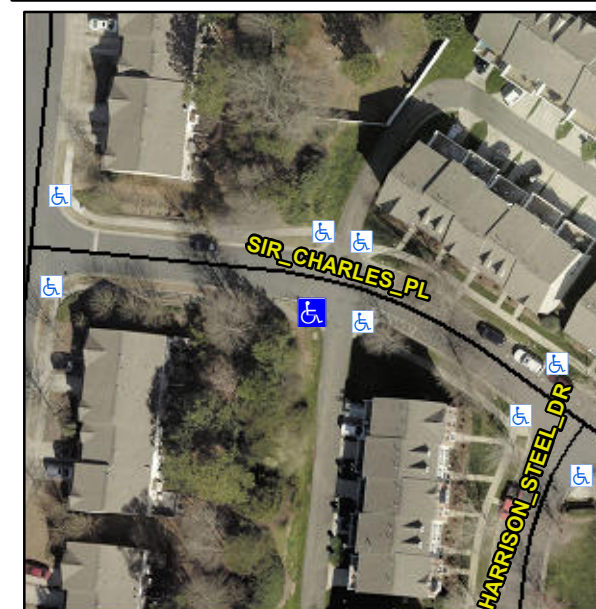
Not Found, R304.5.1

Compliance	Description	Data	Compliance	Description	Data
N/A	Ramp Length (in)	83.0	Yes	BlendTrans Slope (%)	2.8
No	Ramp Width (in)	46.0	Yes	BlendTrans XSlope (%)	1.4
N/A	Flare Type LT	N/A	N/A	Flare Type RT	N/A
N/A	Flare Slope LT (%)	N/A	N/A	Flare Slope RT (%)	N/A
N/A	Flare Traversable LT?	N/A	N/A	Flare Traversable RT?	N/A
N/A	Landing Length (in)	N/A	N/A	DWS Provided?	N/A
N/A	Landing Width (in)	N/A	N/A	DWS Contrast?	N/A
N/A	Landing Slope (%)	N/A	N/A	DWS Length (in)	N/A
N/A	Landing X Slope (%)	N/A	N/A	DWS Full Width?	N/A
N/A	Landing Curb? (Y/N)	N/A	N/A	DWS Offset (in)	N/A
N/A	Shared Landing?	N/A			
N/A	Gutter Ponding?	N/A	N/A	Gutter Slope (%)	N/A
N/A	Gutter Lip Ht (in)	N/A	N/A	Gutter X Slope (%)	N/A
N/A	Painted X Walk1?	No	N/A	Painted X Walk2?	No
	X Walk 1 Direction	To E		X Walk 2 Direction	To N
	X Walk 1 Width (in)	N/A		X Walk 2 Width (in)	N/A
	X Walk 1 Slope (%)	0.7		X Walk 2 Slope (%)	1.9
	X Walk 1 X Slope (%)	0.6		X Walk 2 X Slope (%)	2.6

N/A	Ramp inside XWalk1?	N/A	N/A	Ramp inside XWalk2?	N/A
	Road Slope (%)	2.0		Clear Space?	N/A
	Road X Slope (%)	0.6	N/A	Clear Space to XWalk (in)	N/A
N/A	Any Obstructions?	N/A	N/A	Storm Grate/Utility Hazard?	N/A
	Obstruction Type			Storm Grate/Utility Type	
		N/A			N/A
			Yes	Surface Condition? (G/P)	Good
			No	Curb Slope (%)	6.4

Remove & Replace Curb Ramp With Two New Directional Ramps or Equivalent.

Total Cost: \$ 3200.00
