Access Compliance Report Public Rights-of-Way (Curb Ramps)

Intersection ID: 29986 Main Street: SECRET_GARDEN_LN Cross Street: WINDING_RIVER_DR Location: S

ADA ID: B5C645CEDFC4 Ramp Type: PerpDiag Initial Pass/Fail: Fail Overall Compliance: No Severity Score: 37.5

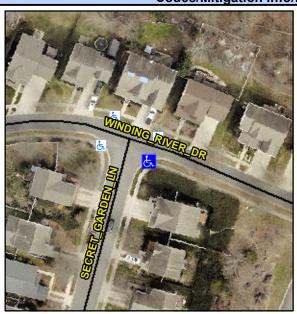
Not Found, R304.2.2, R304.5.3

Compliance Description		Data	Compliance Description		Data	
N/A	Ramp Length (in)	48.0	No	Ramp Slope (%)	8.4	
Yes	Ramp Width (in)	48.0	No	Ramp XSlope (%)	11.1	
N/A	Flare Type LT	N/A	N/A	Flare Type RT	N/A	
N/A	Flare Slope LT (%)	N/A	N/A	Flare Slope RT (%)	N/A	
N/A	Flare Traversable LT?	N/A	N/A	Flare Traversable RT?	N/A	
N/A	Landing Length (in)	N/A	N/A	DWS Provided?	N/A	
N/A	Landing Width (in)	N/A	N/A	DWS Contrast?	N/A	
N/A	Landing Slope (%)	N/A	N/A	DWS Length (in)	N/A	
N/A	Landing X Slope (%)	N/A	N/A	DWS Full Width?	N/A	
N/A	Landing Curb? (Y/N)	N/A	N/A	DWS Offset (in)	N/A	
N/A	Shared Landing?	N/A				
N/A	Gutter Ponding?	N/A	N/A	Gutter Slope (%)	N/A	
N/A	Gutter Lip Ht (in)	N/A	N/A	Gutter X Slope (%)	N/A	
N/A	Painted X Walk1?	No	N/A	Painted X Walk2?	No	
	X Walk 1 Direction	To NE		X Walk 2 Direction	To NW	
N/A	X Walk 1 Width (in)	N/A	N/A	X Walk 2 Width (in)	N/A	
	X Walk 1 Slope (%)	3.4		X Walk 2 Slope (%)	6.5	
	X Walk 1 X Slope (%)	7.9		X Walk 2 X Slope (%)	6.4

Remove & Replace Curb Ramp With Two New Directional Ramps or Equivalent.
