Access Compliance Report

Public Rights-of-Way

(Curb Ramps)

Intersection ID: 2587	Main Street: KILMARTIN_LN	Cross Street: MCCHESENEY_DR	Location: W
ADA ID: B5DECB202A14	Ramp Type: PerpDiag	Initial Pass/Fail: Fail	Overall Compliance: No
Severity Score: 22.5			
Codes/Mitigation Info/Possible Solution		Field Measurements/Component Compliance

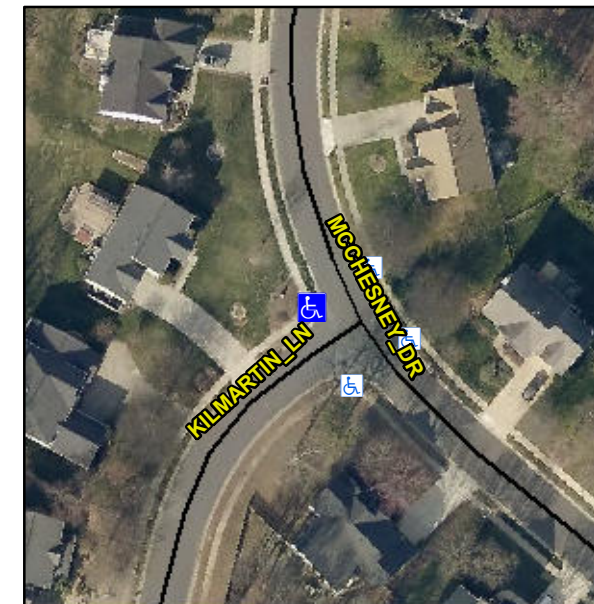
R304.5.1, R304.2.2, R304.5.3

Compliance	Description	Data	Compliance	Description	Data
N/A	Ramp Length (in)	48.0	No	Ramp Slope (%)	11.2
No	Ramp Width (in)	39.5	No	Ramp XSlope (%)	2.5
N/A	Flare Type LT	N/A	N/A	Flare Type RT	N/A
N/A	Flare Slope LT (%)	N/A	N/A	Flare Slope RT (%)	N/A
N/A	Flare Traversable LT?	N/A	N/A	Flare Traversable RT?	N/A
N/A	Landing Length (in)	N/A	N/A	DWS Provided?	N/A
N/A	Landing Width (in)	N/A	N/A	DWS Contrast?	N/A
N/A	Landing Slope (%)	N/A	N/A	DWS Length (in)	N/A
N/A	Landing X Slope (%)	N/A	N/A	DWS Full Width?	N/A
N/A	Landing Curb? (Y/N)	N/A	N/A	DWS Offset (in)	N/A
N/A	Shared Landing?	N/A			
N/A	Gutter Ponding?	N/A	N/A	Gutter Slope (%)	N/A
N/A	Gutter Lip Ht (in)	N/A	N/A	Gutter X Slope (%)	N/A
N/A	Painted X Walk1?	No	N/A	Painted X Walk2?	No
	X Walk 1 Direction	To SE		X Walk 2 Direction	To NE
N/A	X Walk 1 Width (in)	N/A	N/A	X Walk 2 Width (in)	N/A
	X Walk 1 Slope (%)	0.9		X Walk 2 Slope (%)	1.1
	X Walk 1 X Slope (%)	0.9		X Walk 2 X Slope (%)	0.1

N/A	Ramp inside XWalk1?	N/A	N/A	Ramp inside XWalk2?	N/A
	Road Slope (%)	0.9	N/A	Clear Space?	N/A
	Road X Slope (%)	1.7	N/A	Clear Space to XWalk (in)	N/A
N/A	Any Obstructions?	N/A	N/A	Storm Grate/Utility Hazard?	N/A
	Obstruction Type			Storm Grate/Utility Type	
		N/A			N/A
			Yes	Surface Condition? (G/P)	Good

Remove & Replace Curb Ramp With Two New Directional Ramps or Equivalent.
