# Access Compliance Report

## Public Rights-of-Way

### (Curb Ramps)

Intersection ID: 9757	Main Street: HIGHLAKE_DR	Cross Street: THE_PLAZA	Location:	NW
ADA ID: B5E3B851F8C5	Ramp Type: Perp	Initial Pass/Fail: Fail	Overall Compliance: No	Severity Score: 22.5

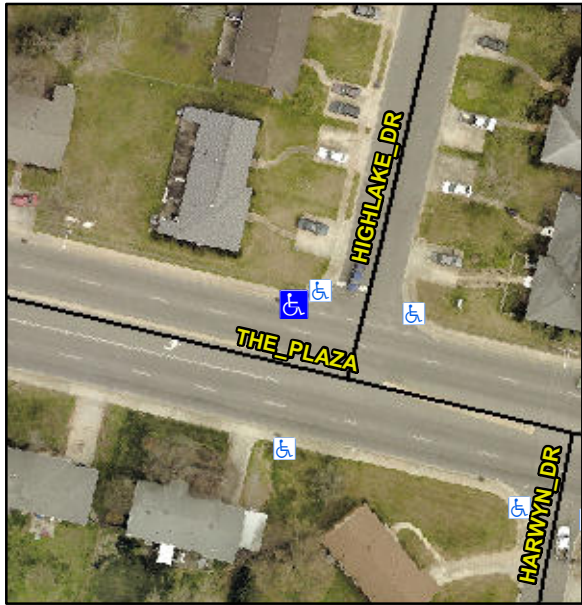
Possible Solutions:		Compliance	Description	Data	Compliance	Description	Data
	Remove & Replace Entire Ramp.		N/A	Ramp Length (in)	53.6	No	Ramp Slope (%)	8.7
			No	Ramp Width (in)	47.5	Yes	Ramp XSlope (%)	4.1
			N/A	Flare Type LT	N/A	N/A	Flare Type RT	N/A
			N/A	Flare Slope LT (%)	N/A	N/A	Flare Slope RT (%)	N/A
			N/A	Flare Traversable LT?	N/A	N/A	Flare Traversable RT?	N/A
			N/A	Landing Length (in)	N/A	N/A	DWS Provided?	N/A
			N/A	Landing Width (in)	N/A	N/A	DWS Contrast?	N/A
			N/A	Landing Slope (%)	N/A	N/A	DWS Length (in)	N/A
			N/A	Landing X Slope (%)	N/A	N/A	DWS Full Width?	N/A
Surveyor Notes:			N/A	Landing Curb? (Y/N)	N/A	N/A	DWS Offset (in)	N/A
N/A			N/A	Shared Landing?	N/A			
PROW/ADA:			N/A	Gutter Ponding?	N/A	N/A	Gutter Slope (%)	N/A
Not Found, R304.5.1, R304.2.2			N/A	Gutter Lip Ht (in)	N/A	N/A	Gutter X Slope (%)	N/A

N/A	Painted X Walk1?	No	N/A	Painted X Walk2?	N/A
				X Walk 1 Direction	To S		X Walk 2 Direction	N/A
			N/A	X Walk 1 Width (in)	N/A	N/A	X Walk 2 Width (in)	N/A
				X Walk 1 Slope (%)	8.7		X Walk 2 Slope (%)	N/A
				X Walk 1 X Slope (%)	4.1		X Walk 2 X Slope (%)	N/A
			N/A	Ramp inside XWalk1?	N/A	N/A	Ramp inside XWalk2?	N/A
				Road Slope (%)	N/A	N/A	Clear Space?	N/A
				Road X Slope (%)	N/A	N/A	Clear Space to XWalk (in)	N/A
			N/A	Any Obstructions?	N/A	N/A	Storm Grate/Utility Hazard?	N/A
				Obstruction Type			Storm Grate/Utility Type	
						N/A		N/A
						Yes	Surface Condition? (G/P)	Good
Total Cost:		\$ 1850.00						
Street 1 Name		THE PLAZA						
Stop Condition-Street 2		None						
Street 2 Name		N/A						
Stop Condition-Street 1		N/A
