# Access Compliance Report

## Public Rights-of-Way

### (Curb Ramps)

| Intersection ID: 53281 | Main Street: BENFIELD_RD | Cross Street: I-485_RA | Location: W |

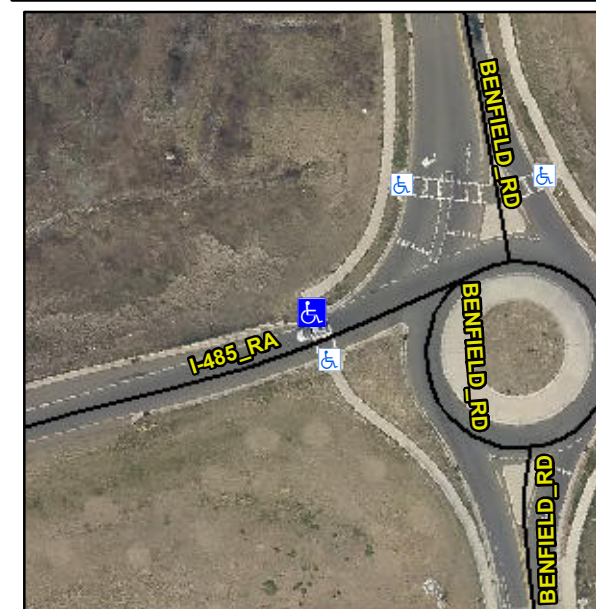
**Remove & Replace Entire Ramp.  
Gutter Ponding Observed.**

**R304.2.2-Perp, R304.3.2-Para,  
R305.2, R302.7**

| Compliance | Description | Data | Compliance | Description | Data |
|---|---|---|---|---|---|
| No | Landing Slope (%) | 3.7 | Yes | DWS Length (in) | 24.0 |
| N/A | Landing Curb? (Y/N) | No | No | DWS Offset (in) | 6.0 |
| No | Gutter Ponding? | Yes | Yes | Gutter Slope (%) | 0.5 |

Possible Solutions:
