Intersection ID: 20991	Main Street: LANSDOWNE_RD	Cross Street: PROVIDENCE_RD	Location:	SE
ADA ID: B5ED0A8F25A5	Ramp Type: ParaDiag	Initial Pass/Fail: Fail	Overall Compliance: No	Severity Score: 26.25

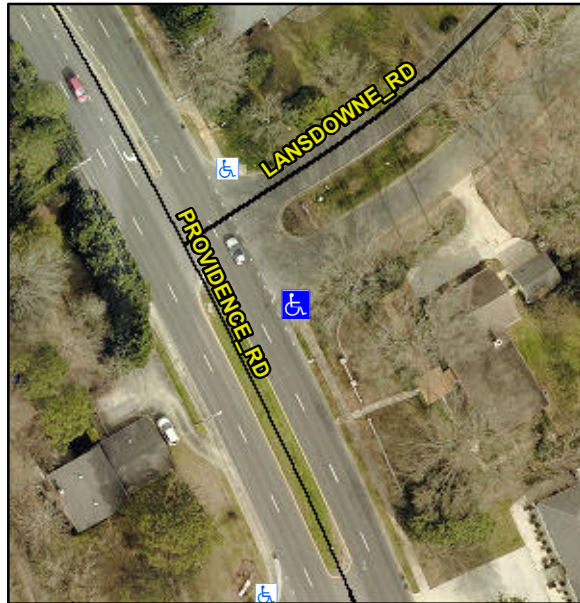
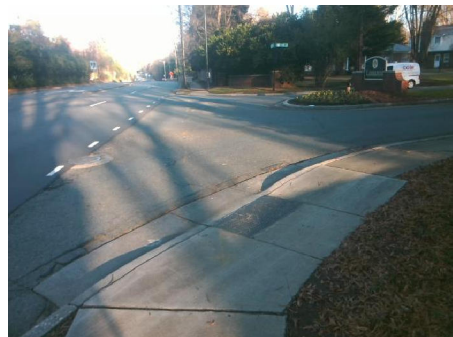
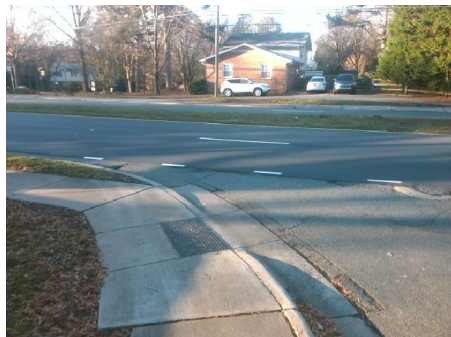
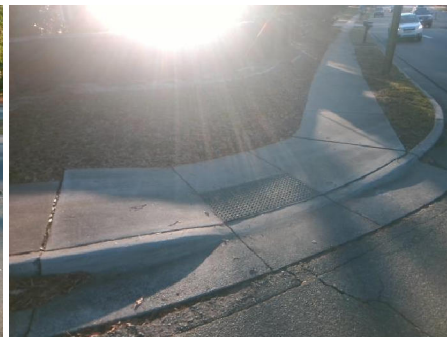
RT RP < 5%

R304.3.2, R304.5.3

Compliance	Description	Data	Compliance	Description	Data
N/A	Ramp Length LT (in)	53.0	N/A	Ramp Length RT (in)	37.0
Yes	Ramp Width LT (in)	60.0	Yes	Ramp Width RT (in)	59.0
No	Ramp Slope LT (%)	17.6	Yes	Ramp Slope RT (%)	0.2
Yes	Ramp XSlope LT (%)	0.2	No	Ramp XSlope RT (%)	2.5
N/A	Landing Length (in)	N/A	N/A	DWS Provided?	N/A
N/A	Landing Width (in)	N/A	N/A	DWS Contrast?	N/A
N/A	Landing Slope (%)	N/A	N/A	DWS Length (in)	N/A
N/A	Landing X Slope (%)	N/A	N/A	DWS Full Width?	N/A
N/A	Landing Curb? (Y/N)	N/A	N/A	DWS Offset (in)	N/A
N/A	Shared Landing?	N/A			
N/A	Gutter Ponding?	N/A	N/A	Gutter Slope (%)	N/A
N/A	Gutter Lip Ht (in)	N/A	N/A	Gutter X Slope (%)	N/A
N/A	Painted X Walk1?	No	N/A	Painted X Walk2?	No
	X Walk 1 Direction	To NW		X Walk 2 Direction	To SW
N/A	X Walk 1 Width (in)	N/A	N/A	X Walk 2 Width (in)	N/A
	X Walk 1 Slope (%)	2.9		X Walk 2 Slope (%)	0.1
	X Walk 1 X Slope (%)	2.0		X Walk 2 X Slope (%)	2.9
N/A	Ramp inside XWalk1?	N/A	N/A	Ramp inside XWalk2?	N/A

Road Slope (%)	4.0	N/A	Clear Space?	N/A
	Road X Slope (%)	2.3	N/A	Clear Space to XWalk (in)	N/A
N/A	Any Obstructions?	N/A	N/A	Storm Grate/Utility Hazard?	N/A
	Obstruction Type			Storm Grate/Utility Type	
		N/A			N/A
			Yes	Surface Condition? (G/P)	Good
			N/A	Curb Slope (%)	6.3

Remove & Replace Curb Ramp With Two New Directional Ramps or Equivalent.
