# Access Compliance Report

## Public Rights-of-Way

### (Curb Ramps)

Intersection ID: 47844	Main Street: DEL_RIO_RD	Cross Street: SERAPE_RD	Location: NW
ADA ID: B5EFC950A254	Ramp Type: Perp	Initial Pass/Fail: Fail	Overall Compliance: No
		Severity Score: 8.75

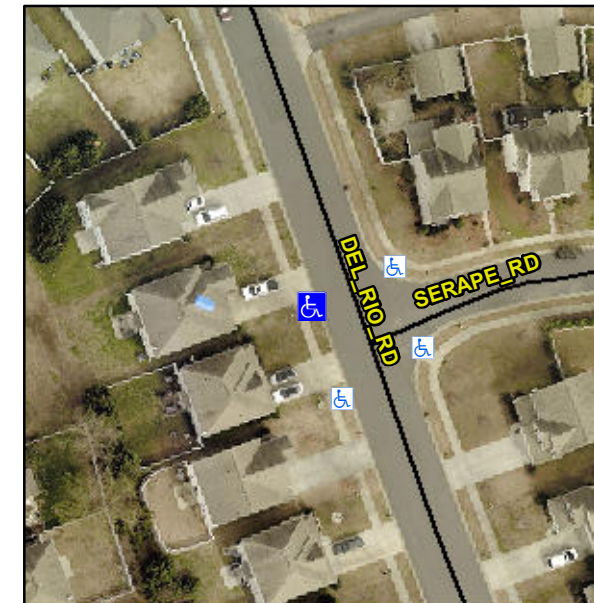
**Not Found, R304.5.1**

Compliance	Description	Data	Compliance	Description	Data
N/A	Ramp Length (in)	72.0	Yes	Ramp Slope (%)	6.0
No	Ramp Width (in)	46.5	Yes	Ramp XSlope (%)	1.5
N/A	Flare Type LT	N/A	N/A	Flare Type RT	N/A
N/A	Flare Slope LT (%)	N/A	N/A	Flare Slope RT (%)	N/A
N/A	Flare Traversable LT?	N/A	N/A	Flare Traversable RT?	N/A
N/A	Landing Length (in)	N/A	N/A	DWS Provided?	N/A
N/A	Landing Width (in)	N/A	N/A	DWS Contrast?	N/A
N/A	Landing Slope (%)	N/A	N/A	DWS Length (in)	N/A
N/A	Landing X Slope (%)	N/A	N/A	DWS Full Width?	N/A
N/A	Landing Curb? (Y/N)	N/A	N/A	DWS Offset (in)	N/A
N/A	Shared Landing?	N/A			
N/A	Gutter Ponding?	N/A	N/A	Gutter Slope (%)	N/A
N/A	Gutter Lip Ht (in)	N/A	N/A	Gutter X Slope (%)	N/A
N/A	Painted X Walk1?	No	N/A	Painted X Walk2?	N/A
	X Walk 1 Direction	To E		X Walk 2 Direction	N/A
N/A	X Walk 1 Width (in)	N/A	N/A	X Walk 2 Width (in)	N/A
	X Walk 1 Slope (%)	2.6		X Walk 2 Slope (%)	N/A
	X Walk 1 X Slope (%)	1.6		X Walk 2 X Slope (%)	N/A

N/A	Ramp inside XWalk1?	N/A	N/A	Ramp inside XWalk2?	N/A
	Road Slope (%)	N/A	N/A	Clear Space?	N/A
	Road X Slope (%)	N/A	N/A	Clear Space to XWalk (in)	N/A
N/A	Any Obstructions?	N/A	N/A	Storm Grate/Utility Hazard?	N/A
	Obstruction Type			Storm Grate/Utility Type	
		N/A			N/A
			Yes	Surface Condition? (G/P)	Good

**Remove & Replace Entire Ramp.**

Total Cost: \$ 1850.00
