# Access Compliance Report

## Public Rights-of-Way

### (Curb Ramps)

Intersection ID: 28212	Main Street: CHASEWATER_DR	Cross Street: DARBY_CHASE_DR	Location: S
ADA ID: B5F8FC72C2C6	Ramp Type: Perp	Initial Pass/Fail: Fail	Overall Compliance: No
			Severity Score: 1.25

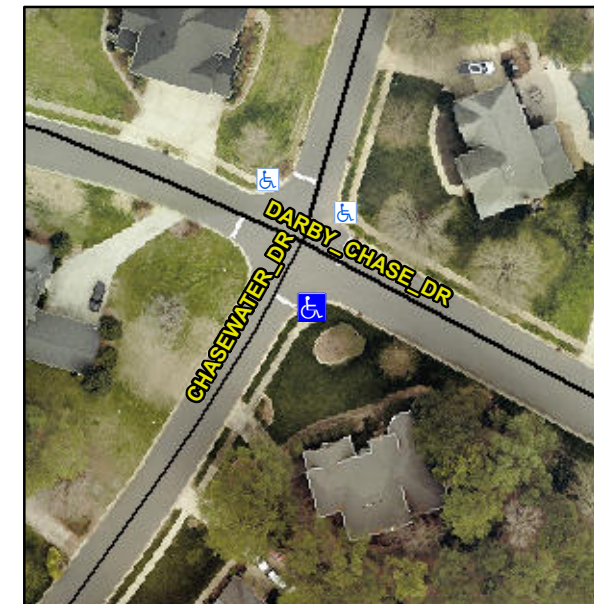
**Not Found, R304.5.3**

Compliance	Description	Data	Compliance	Description	Data
N/A	Ramp Length (in)	48.0	Yes	Ramp Slope (%)	5.1
Yes	Ramp Width (in)	48.0	No	Ramp XSlope (%)	3.6
N/A	Flare Type LT	N/A	N/A	Flare Type RT	N/A
N/A	Flare Slope LT (%)	N/A	N/A	Flare Slope RT (%)	N/A
N/A	Flare Traversable LT?	N/A	N/A	Flare Traversable RT?	N/A
N/A	Landing Length (in)	N/A	N/A	DWS Provided?	N/A
N/A	Landing Width (in)	N/A	N/A	DWS Contrast?	N/A
N/A	Landing Slope (%)	N/A	N/A	DWS Length (in)	N/A
N/A	Landing X Slope (%)	N/A	N/A	DWS Full Width?	N/A
N/A	Landing Curb? (Y/N)	N/A	N/A	DWS Offset (in)	N/A
N/A	Shared Landing?	N/A			
N/A	Gutter Ponding?	N/A	N/A	Gutter Slope (%)	N/A
N/A	Gutter Lip Ht (in)	N/A	N/A	Gutter X Slope (%)	N/A
N/A	Painted X Walk1?	No	N/A	Painted X Walk2?	N/A
	X Walk 1 Direction	To NE		X Walk 2 Direction	N/A
N/A	X Walk 1 Width (in)	N/A	N/A	X Walk 2 Width (in)	N/A
	X Walk 1 Slope (%)	4.2		X Walk 2 Slope (%)	N/A
	X Walk 1 X Slope (%)	0.5		X Walk 2 X Slope (%)	N/A

N/A	Ramp inside XWalk1?	N/A	N/A	Ramp inside XWalk2?	N/A
	Road Slope (%)	N/A	N/A	Clear Space?	N/A
	Road X Slope (%)	N/A	N/A	Clear Space to XWalk (in)	N/A
N/A	Any Obstructions?	N/A	N/A	Storm Grate/Utility Hazard?	N/A
	Obstruction Type			Storm Grate/Utility Type	
		N/A			N/A
			Yes	Surface Condition? (G/P)	Good

**Remove & Replace Entire Ramp.**
