Access Compliance Report

Public Rights-of-Way

(Curb Ramps)

Intersection ID: 27323	Main Street: MEADOW_RUN_LN	Cross Street: THORNHILL_CLUB_DR	Location: SW
ADA ID: B5FA6C1921F9	Ramp Type: Perp	Initial Pass/Fail: Fail	Overall Compliance: No
Severity Score: 10			
Codes/Mitigation Info/Possible Solution		Field Measurements/Component Compliance

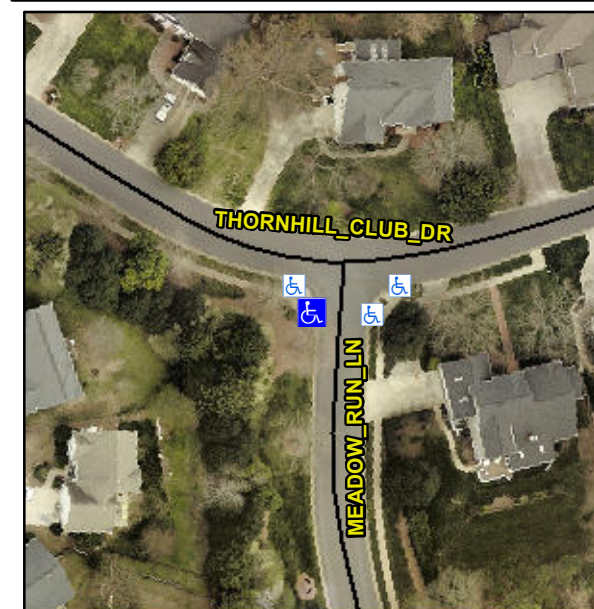
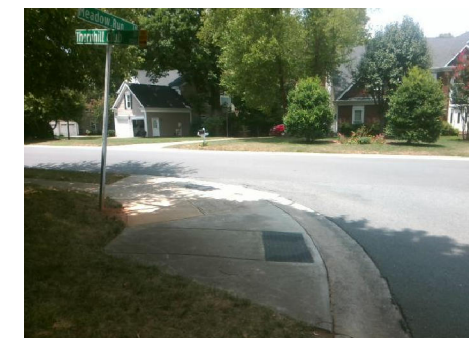
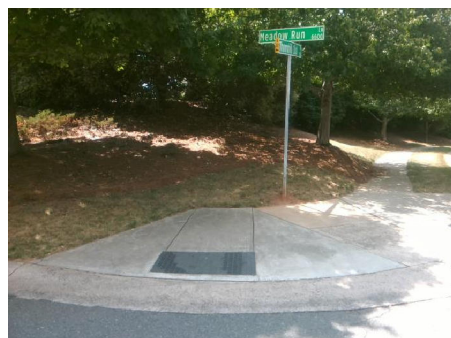
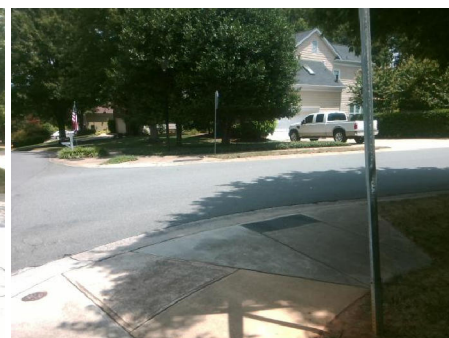
Not Found, R304.5.1, R304.5.3

Compliance	Description	Data	Compliance	Description	Data
N/A	Ramp Length (in)	110.0	Yes	Ramp Slope (%)	7.2
No	Ramp Width (in)	42.5	No	Ramp XSlope (%)	2.5
N/A	Flare Type LT	N/A	N/A	Flare Type RT	N/A
N/A	Flare Slope LT (%)	N/A	N/A	Flare Slope RT (%)	N/A
N/A	Flare Traversable LT?	N/A	N/A	Flare Traversable RT?	N/A
N/A	Landing Length (in)	N/A	N/A	DWS Provided?	N/A
N/A	Landing Width (in)	N/A	N/A	DWS Contrast?	N/A
N/A	Landing Slope (%)	N/A	N/A	DWS Length (in)	N/A
N/A	Landing X Slope (%)	N/A	N/A	DWS Full Width?	N/A
N/A	Landing Curb? (Y/N)	N/A	N/A	DWS Offset (in)	N/A
N/A	Shared Landing?	N/A			
N/A	Gutter Ponding?	N/A	N/A	Gutter Slope (%)	N/A
N/A	Gutter Lip Ht (in)	N/A	N/A	Gutter X Slope (%)	N/A
N/A	Painted X Walk1?	No	N/A	Painted X Walk2?	N/A
	X Walk 1 Direction	To E		X Walk 2 Direction	N/A
N/A	X Walk 1 Width (in)	N/A	N/A	X Walk 2 Width (in)	N/A
	X Walk 1 Slope (%)	0.7		X Walk 2 Slope (%)	N/A
	X Walk 1 X Slope (%)	1.2		X Walk 2 X Slope (%)	N/A

N/A	Ramp inside XWalk1?	N/A	N/A	Ramp inside XWalk2?	N/A
	Road Slope (%)	N/A	N/A	Clear Space?	N/A
	Road X Slope (%)	N/A	N/A	Clear Space to XWalk (in)	N/A
N/A	Any Obstructions?	N/A	N/A	Storm Grate/Utility Hazard?	N/A
	Obstruction Type			Storm Grate/Utility Type	
		N/A			N/A
			Yes	Surface Condition? (G/P)	Good

Possible Solutions:

Remove & Replace Entire Ramp.

Total Cost: \$ 1850.00
