Access Compliance Report

Public Rights-of-Way

(Curb Ramps)

Intersection ID: 52931	Main Street: WALTHAM_LN	Cross Street: GRAY_OAK_LN	Location:	N
ADA ID: B5FE639A07CB	Ramp Type: Perp	Initial Pass/Fail: Pass	Overall Compliance: No	Severity Score: 0
Codes/Mitigation Info/Possible Solution		Field Measurements/Component Compliance

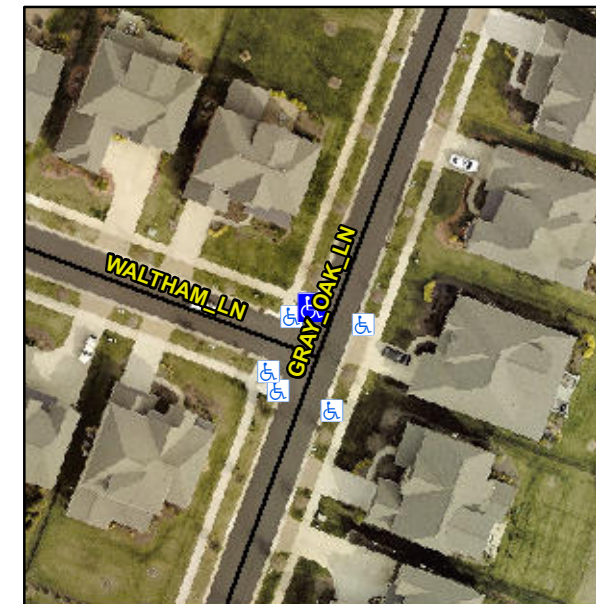
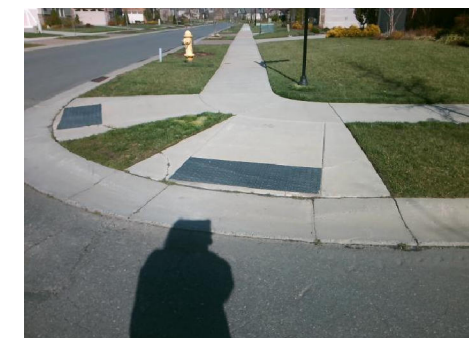
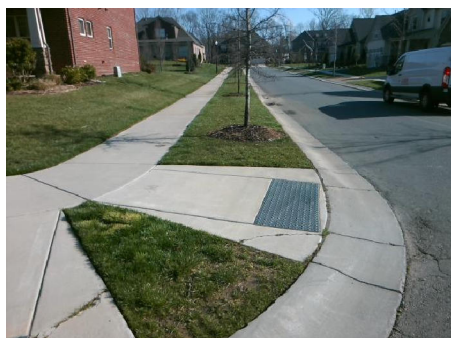
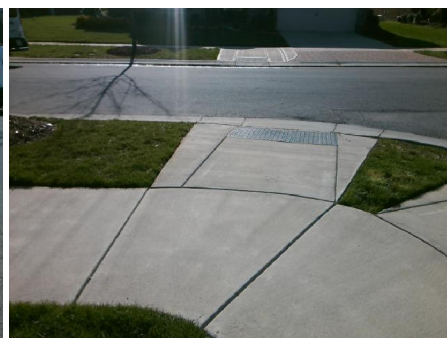
Not Found, R304.5.3, R305.2

Compliance	Description	Data	Compliance	Description	Data
N/A	Ramp Length (in)	96.0	Yes	Ramp Slope (%)	5.1
Yes	Ramp Width (in)	56.0	Yes	Ramp XSlope (%)	0.9
N/A	Flare Type LT	Sloped	N/A	Flare Type RT	N/A
N/A	Flare Slope LT (%)	1.5	N/A	Flare Slope RT (%)	2.4
N/A	Flare Traversable LT?	Yes	N/A	Flare Traversable RT?	No
Yes	Landing Length (in)	60.0	Yes	DWS Provided?	Yes
Yes	Landing Width (in)	56.0	Yes	DWS Contrast?	Yes
Yes	Landing Slope (%)	1.3	Yes	DWS Length (in)	24.0
No	Landing X Slope (%)	3.2	Yes	DWS Full Width?	Yes
N/A	Landing Curb? (Y/N)	No	No	DWS Offset (in)	5.0
N/A	Shared Landing?	No			
Yes	Gutter Ponding?	No	Yes	Gutter Slope (%)	1.4
Yes	Gutter Lip Ht (in)	0.0	Yes	Gutter X Slope (%)	1.7
N/A	Painted X Walk1?	No	N/A	Painted X Walk2?	N/A
	X Walk 1 Direction	To SE		X Walk 2 Direction	N/A
N/A	X Walk 1 Width (in)	N/A	N/A	X Walk 2 Width (in)	N/A
	X Walk 1 Slope (%)	4.0		X Walk 2 Slope (%)	N/A
	X Walk 1 X Slope (%)	2.4		X Walk 2 X Slope (%)	N/A

N/A	Ramp inside XWalk1?	N/A	N/A	Ramp inside XWalk2?	N/A
	Road Slope (%)	N/A	N/A	Clear Space?	Yes
	Road X Slope (%)	N/A	N/A	Clear Space to XWalk (in)	N/A
Yes	Any Obstructions?	No	Yes	Storm Grate/Utility Hazard?	No
	Obstruction Type			Storm Grate/Utility Type	
		N/A			N/A
			Yes	Surface Condition? (G/P)	Good

Remove & Replace Entire Ramp.
